# Access Compliance Report

## Public Rights-of-Way

### (Curb Ramps)

Intersection ID: 53963	Main Street: MAGNOLIA LILY AV	Cross Street: LILAC TREE AV	Location: SE
ADA ID: 5F0230522816	Ramp Type: Perp	Initial Pass/Fail: Fail	Overall Compliance: No
Severity Score: 8.75			
Codes/Mitigation Info/Possible Solution		Field Measurements/Component Compliance

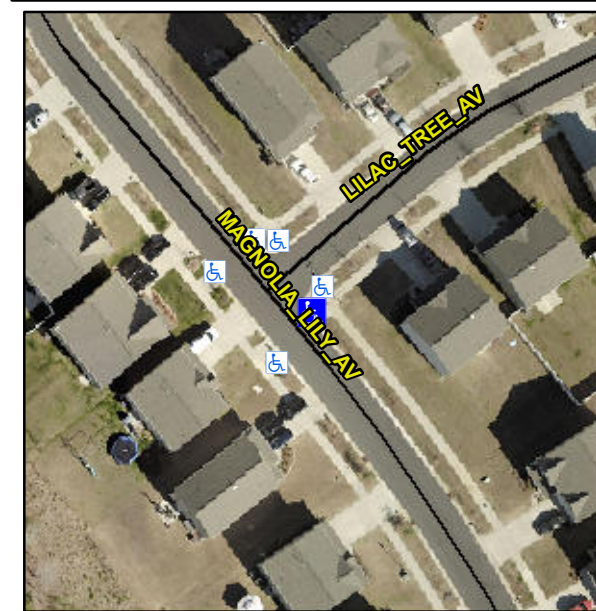
**Not Found, R304.5.1**

Compliance	Description	Data	Compliance	Description	Data
N/A	Ramp Length (in)	108.0	Yes	Ramp Slope (%)	7.6
No	Ramp Width (in)	38.5	Yes	Ramp XSlope (%)	1.0
N/A	Flare Type LT	N/A	N/A	Flare Type RT	N/A
N/A	Flare Slope LT (%)	N/A	N/A	Flare Slope RT (%)	N/A
N/A	Flare Traversable LT?	N/A	N/A	Flare Traversable RT?	N/A
N/A	Landing Length (in)	N/A	N/A	DWS Provided?	N/A
N/A	Landing Width (in)	N/A	N/A	DWS Contrast?	N/A
N/A	Landing Slope (%)	N/A	N/A	DWS Length (in)	N/A
N/A	Landing X Slope (%)	N/A	N/A	DWS Full Width?	N/A
N/A	Landing Curb? (Y/N)	N/A	N/A	DWS Offset (in)	N/A
N/A	Shared Landing?	N/A			
N/A	Gutter Ponding?	N/A	N/A	Gutter Slope (%)	N/A
N/A	Gutter Lip Ht (in)	1.0	N/A	Gutter X Slope (%)	N/A
N/A	Painted X Walk1?	No	N/A	Painted X Walk2?	N/A
	X Walk 1 Direction	To W		X Walk 2 Direction	N/A
N/A	X Walk 1 Width (in)	N/A	N/A	X Walk 2 Width (in)	N/A
	X Walk 1 Slope (%)	3.6		X Walk 2 Slope (%)	N/A
	X Walk 1 X Slope (%)	1.1		X Walk 2 X Slope (%)	N/A

**Remove & Replace Entire Ramp.**

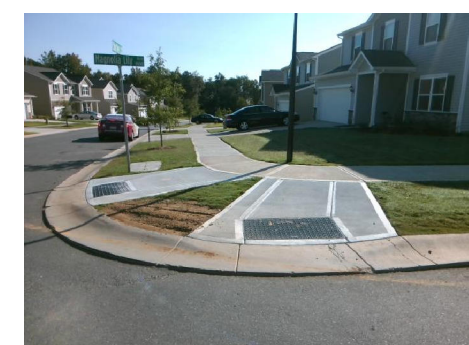
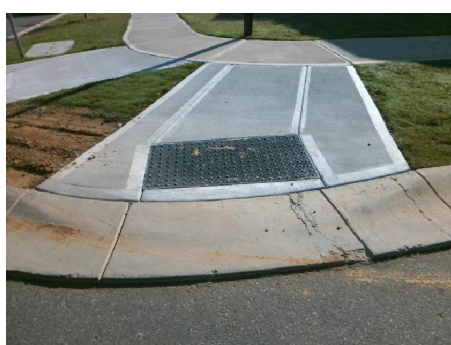
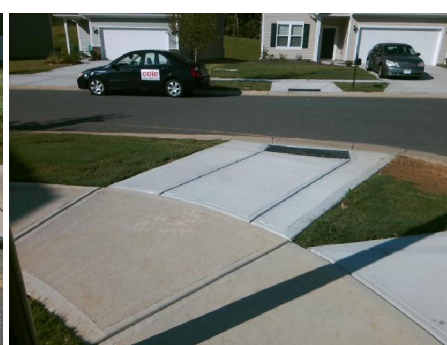
N/A	Ramp inside XWalk1?	N/A	N/A	Ramp inside XWalk2?	N/A
	Road Slope (%)	N/A	N/A	Clear Space?	N/A
	Road X Slope (%)	N/A	N/A	Clear Space to XWalk (in)	N/A
N/A	Any Obstructions?	N/A	N/A	Storm Grate/Utility Hazard?	N/A
	Obstruction Type			Storm Grate/Utility Type	
		N/A			N/A
			Yes	Surface Condition? (G/P)	Good
