Access Compliance Report Public Rights-of-Way (Curb Ramps)

Intersection ID: 13654 Main Street: S_TRYON_ST Cross Street: W_PARK_AV Location: N **Overall Compliance: No Severity Score:** ADA ID: 5F37D66768F9 Ramp Type: Perp Initial Pass/Fail: Fail 12.5

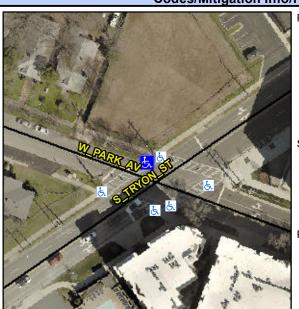
Field Measurements/Component Compliance								
Compl	iance Description	Data	Comp	liance	Description	Data		
N/A	Ramp Length (in)	124.0	Yes	Ram	o Slope (%)	7.7		
Yes	Ramp Width (in)	55.0	No	Ram	xSlope (%)	5.2		
N/A	Flare Type LT	N/A	N/A	Flare	Type RT	N/A		
N/A	Flare Slope LT (%)	N/A	N/A	Flare	Slope RT (%)	N/A		
N/A	Flare Traversable LT?	N/A	N/A	Flare	Traversable RT?	N/A		
N/A	Landing Length (in)	N/A	N/A	DWS	Provided?	N/A		
N/A	Landing Width (in)	N/A	N/A	DWS	Contrast?	N/A		
N/A	Landing Slope (%)	N/A	N/A	DWS	Length (in)	N/A		
N/A	Landing X Slope (%)	N/A	N/A	DWS	Full Width?	N/A		
N/A	Landing Curb? (Y/N)	N/A	N/A	DWS	Offset (in)	N/A		
N/A	Shared Landing?	N/A						
N/A	Gutter Ponding?	N/A	N/A	Gutte	er Slope (%)	N/A		
N/A	Gutter Lip Ht (in)	N/A	N/A	Gutte	er X Slope (%)	N/A		
N/A	Painted X Walk1?	Yes	N/A	Paint	ed X Walk2?	N/A		
	X Walk 1 Direction	To SW		X Wa	lk 2 Direction	N/A		
N/A	X Walk 1 Width (in)	104.0	N/A	X Wa	ılk 2 Width (in)	N/A

X Walk 1 Slope (%)	0.2		X Wa	ılk 2 Slope (%)	N/A		
	X Walk 1 X Slope (%)	2.7		X Wa	ılk 2 X Slope (%)	N/A		
N/A	Ramp inside XWalk1?	Yes	N/A	Ram	p inside XWalk2?	N/A		
	Road Slope (%)	N/A	N/A	Clear	Space?	N/A		
	Road X Slope (%)	N/A	N/A	Clear	Space to XWalk (in)	N/A		
N/A	Any Obstructions?	N/A	N/A	Storn	n Grate/Utility Hazard?	N/A		
	Obstruction Type			Storn	n Grate/Utility Type			
		N/A				N/A		
			Yes	Surfa	ice Condition? (G/P)	Good

Possible Solutions:	Co
Remove & Replace Entire Ramp.	N/A
	Yes
	N/A
	N/A
	N/A
	N/A
Surveyor Notes:	N/A
N/A	N/A
	N/A
	N/A
	N/A
PROW/ADA:	N/A
Not Found, R304.5.3	N/A
	N/A
	N/A
	N/A
