Access Compliance Report Public Rights-of-Way (Curb Ramps)

Intersection ID: 6013 Main Street: BALANCING_ROCK_CT Cross Street: CHIMNEY_ROCK_CT Location: **ADA ID: 5F4E771D5FF0** Ramp Type: Directional1 Initial Pass/Fail: Fail **Overall Compliance: No** Severity Score: 26.25

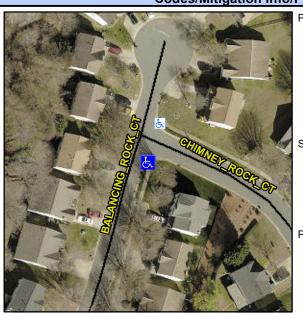
Field Measurements/Component Compliance								
Comp	liance Description	Data	Comp	oliance Description	Data			
N/A	Ramp Length (in)	57.0	N/A	Grade Break?	N/A			
Yes	Ramp Width (in)	54.0	N/A	Grade Break Slope (%)	0.0			
No	Ramp Slope (%)	13.4	N/A	Grade Break XSlope (%)	0.0			
No	Ramp XSlope (%)	3.1						
N/A	Flare Type LT	N/A	N/A	Flare Type RT	N/A			
N/A	Flare Slope LT (%)	N/A	N/A	Flare Slope RT (%)	0.0			
N/A	Flare Traversable LT?	N/A	N/A	Flare Traversable RT?	N/A			
N/A	Landing Length (in)	0.0	N/A	DWS Provided?	N/A			
N/A	Landing Width (in)	0.0	N/A	DWS Contrast?	N/A			
N/A	Landing Slope (%)	0.0	N/A	DWS Length (in)	N/A			
N/A	Landing X Slope (%)	0.0	N/A	DWS Full Width?	N/A			
N/A	Landing Curb? (Y/N)	N/A	N/A	DWS Offset LT (in)	N/A			
N/A	Shared Landing?	N/A	N/A	DWS Offset RT (in)	N/A			
N/A	Gutter Ponding?	0.0	N/A	Gutter Slope (%)	N/A			
N/A	Gutter Lip Ht (in)	0.5	N/A	Gutter X Slope (%)	N/A			
N/A	Painted X Walk1?	No		Road Slope (%)	3.7

X Walk 1 Direction	To N		Road X Slope (%)	0.4			
	X Walk 1 Width (in)	N/A		Clear Space?	N/A			
	X Walk 1 Slope (%)	3.7	N/A	Clear Space to XWalk (in)	N/A			
	X Walk 1 X Slope (%)	0.4	N/A	Storm Grate/Utility Hazard?	N/A			
N/A	Ramp inside XWalk1?	N/A		Storm Grate/Utility Type				
N/A	Any Obstructions?	N/A			N/A			
	Obstruction Type		Yes	Surface Condition? (G/P)	Good			
		N/A	N/A	Curb Slope (%)	16.3

russible solution			
Possible Solutions:	Co		
Remove & Replace Entire Ramp.			
	Ye		
	No		
	No		
	N/A		
	N/A		
Surveyor Notes:	N/A		
N/A	N/A		
	N/A		
	N/A		
	N/A		
PROW/ADA:	N/A		
R304.2.2, R304.5.3	N/A

N
PROW/ADA:			N
R304.2.2, R304.5.3			N
			N
			N
			N
			N
			N
Total Cost:	\$	1600.00
