Access Compliance Report

Public Rights-of-Way

(Curb Ramps)

Intersection ID: 14278	Main Street: ROMARE_BEARDEN_DR	Cross Street: FARMER_ST	Location: NW
ADA ID: 5FB6682169FE	Ramp Type: Perp	Initial Pass/Fail: Fail	Overall Compliance: No
Severity Score: 13.75			
Codes/Mitigation Info/Possible Solution		Field Measurements/Component Compliance

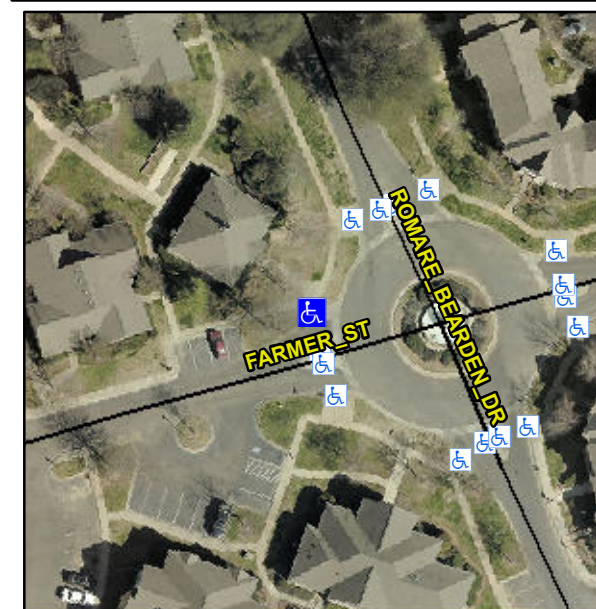
R304.2.2, R304.5.3

Compliance	Description	Data	Compliance	Description	Data
N/A	Ramp Length (in)	77.0	No	Ramp Slope (%)	9.1
Yes	Ramp Width (in)	50.0	No	Ramp XSlope (%)	3.7
N/A	Flare Type LT	N/A	N/A	Flare Type RT	N/A
N/A	Flare Slope LT (%)	N/A	N/A	Flare Slope RT (%)	N/A
N/A	Flare Traversable LT?	N/A	N/A	Flare Traversable RT?	N/A
N/A	Landing Length (in)	N/A	N/A	DWS Provided?	N/A
N/A	Landing Width (in)	N/A	N/A	DWS Contrast?	N/A
N/A	Landing Slope (%)	N/A	N/A	DWS Length (in)	N/A
N/A	Landing X Slope (%)	N/A	N/A	DWS Full Width?	N/A
N/A	Landing Curb? (Y/N)	N/A	N/A	DWS Offset (in)	N/A
N/A	Shared Landing?	N/A			
N/A	Gutter Ponding?	N/A	N/A	Gutter Slope (%)	N/A
N/A	Gutter Lip Ht (in)	N/A	N/A	Gutter X Slope (%)	N/A
N/A	Painted X Walk1?	No	N/A	Painted X Walk2?	N/A
	X Walk 1 Direction	To S		X Walk 2 Direction	N/A
N/A	X Walk 1 Width (in)	N/A	N/A	X Walk 2 Width (in)	N/A
	X Walk 1 Slope (%)	1.3		X Walk 2 Slope (%)	N/A
	X Walk 1 X Slope (%)	0.7		X Walk 2 X Slope (%)	N/A

Remove & Replace Entire Ramp.
