Access Compliance Report

Public Rights-of-Way

(Curb Ramps)

Intersection ID: 54402	Main Street: SPRINGMAN_LN	Cross Street: LOMA_LINDA_LN	Location: SW
ADA ID: 5FD3E961572A	Ramp Type: Perp	Initial Pass/Fail: Fail	Overall Compliance: No
Severity Score: 8.75			
Codes/Mitigation Info/Possible Solution		Field Measurements/Component Compliance

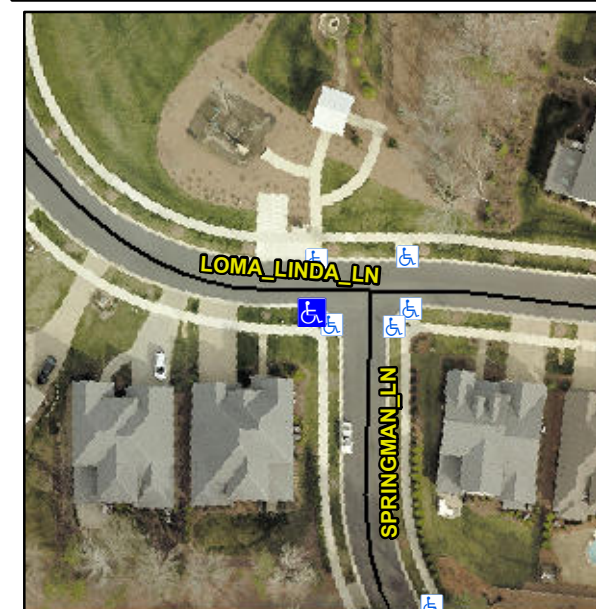
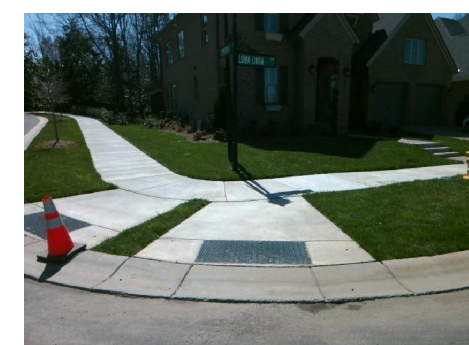
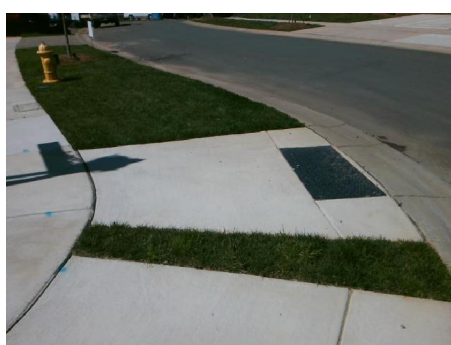
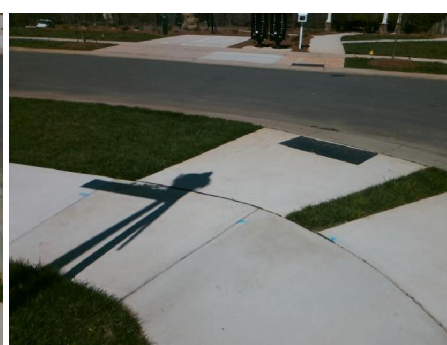
Not Found, R304.5.1

Compliance	Description	Data	Compliance	Description	Data
N/A	Ramp Length (in)	93.0	Yes	Ramp Slope (%)	5.2
No	Ramp Width (in)	47.0	Yes	Ramp XSlope (%)	1.9
N/A	Flare Type LT	N/A	N/A	Flare Type RT	N/A
N/A	Flare Slope LT (%)	N/A	N/A	Flare Slope RT (%)	N/A
N/A	Flare Traversable LT?	N/A	N/A	Flare Traversable RT?	N/A
N/A	Landing Length (in)	N/A	N/A	DWS Provided?	N/A
N/A	Landing Width (in)	N/A	N/A	DWS Contrast?	N/A
N/A	Landing Slope (%)	N/A	N/A	DWS Length (in)	N/A
N/A	Landing X Slope (%)	N/A	N/A	DWS Full Width?	N/A
N/A	Landing Curb? (Y/N)	N/A	N/A	DWS Offset (in)	N/A
N/A	Shared Landing?	N/A			
N/A	Gutter Ponding?	N/A	N/A	Gutter Slope (%)	N/A
N/A	Gutter Lip Ht (in)	N/A	N/A	Gutter X Slope (%)	N/A
N/A	Painted X Walk1?	No	N/A	Painted X Walk2?	N/A
	X Walk 1 Direction	To N		X Walk 2 Direction	N/A
N/A	X Walk 1 Width (in)	N/A	N/A	X Walk 2 Width (in)	N/A
	X Walk 1 Slope (%)	0.1		X Walk 2 Slope (%)	N/A
	X Walk 1 X Slope (%)	2.5		X Walk 2 X Slope (%)	N/A

N/A	Ramp inside XWalk1?	N/A	N/A	Ramp inside XWalk2?	N/A
	Road Slope (%)	N/A	N/A	Clear Space?	N/A
	Road X Slope (%)	N/A	N/A	Clear Space to XWalk (in)	N/A
N/A	Any Obstructions?	N/A	N/A	Storm Grate/Utility Hazard?	N/A
	Obstruction Type			Storm Grate/Utility Type	
		N/A			N/A
			Yes	Surface Condition? (G/P)	Good

Remove & Replace Entire Ramp.
