# Access Compliance Report

## Public Rights-of-Way

| Intersection ID: 42489 | Main Street: ALEXANDER MARTIN AV | Cross Street: LINA ARDREY LN | Location: NE |
| ADA ID: 5FDACAFCD0B3 | Ramp Type: Combination1Diag | Initial Pass/Fail: Fail | Overall Compliance: No |

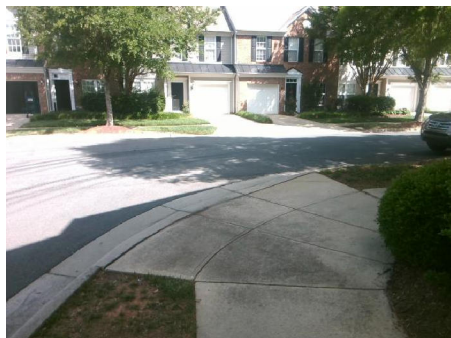
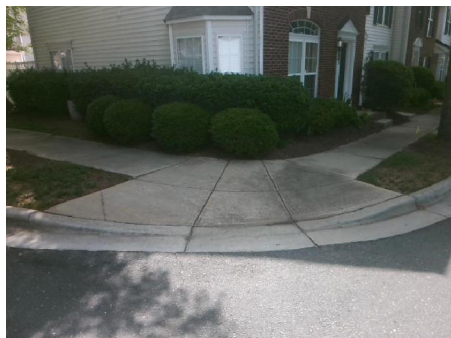
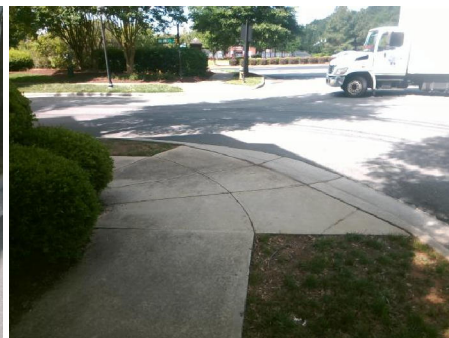
**RP & RT RP < 5%**

**R304.5.1, R304.5.3**

| Compliance | Description | Data | Compliance | Description | Data |
|---|---|---|---|---|---|
| No | Ramp XSlope LT (%) | 2.6 | No | Ramp XSlope RT (%) | 2.6 |
| No | Ramp Width (in) | 37.0 | No | Ramp XSlope (%) | 4.5 |

**Remove & Replace Curb Ramp With Two New Directional Ramps or Equivalent.**
