## **Access Compliance Report Public Rights-of-Way** (Curb Ramps)

Intersection ID: 5980 Main Street: SUTHER RD Cross Street: MARGIE\_ANN\_DR Location: ADA ID: 5FDF66F9BDA7 Ramp Type: Perp Initial Pass/Fail: Fail **Overall Compliance: No Severity Score:** 8.75

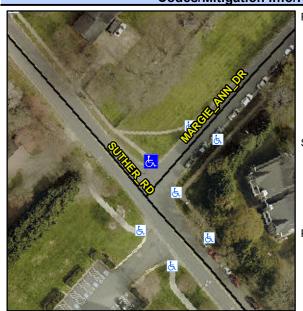
Street 1 Name **MARGIE ANN DR** Stop Condition-Street 2 StopSign Street 2 Name N/A Stop Condition-Street 1 N/A Possible Solutions: Remove & Replace Entire Ramp. Surveyor Notes: N/A PROW/ADA: Not Found, R304.5.1

| Field Measurements/Component Compliance | | | | | |
|---|---|---|---|---|---|
| No | Ramp Width (in) | 45.0 | Yes | Ramp XSlope (%) | 0.3 |
