# Access Compliance Report

## Public Rights-of-Way

### (Curb Ramps)

| Intersection ID: 50321 | Main Street: BELMAR_PLACE_RD | Cross Street: CINDY_LN | Location: SE |

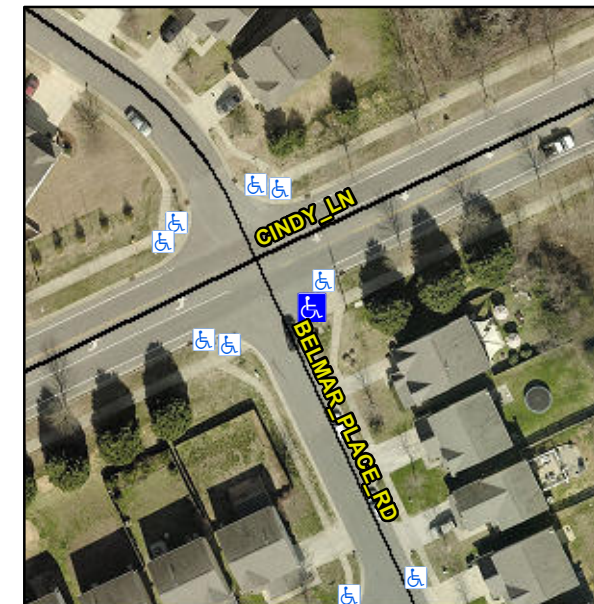
| ADA ID: 60272EC37590 | Ramp Type: Directional1 | Initial Pass/Fail: Pass | Overall Compliance: No |
| Severity Score: 10 | | | |

**Not Found, R305.1.4, R305.2,  
R302.7.2, R304.5.3**

| Compliance | Description | Data | Compliance | Description | Data |
|---|---|---|---|---|---|
| Yes | Landing X Slope (%) | 0.9 | No | DWS Full Width? | No |
| No | Gutter Lip Ht (in) | 0.3 | No | Gutter X Slope (%) | 2.7 |

Possible Solutions:

**Remove & Replace Entire Ramp.  
Remove & Replace Gutter.**
