## Access Compliance Report Public Rights-of-Way (Curb Ramps)

Intersection ID: 8908 Main Street: RUSSELL\_AV Cross Street: WELCH\_PL Location: SW

ADA ID: 604467C34D92 Ramp Type: BlendTrans2 Initial Pass/Fail: Fail Overall Compliance: No Severity Score: 12.5

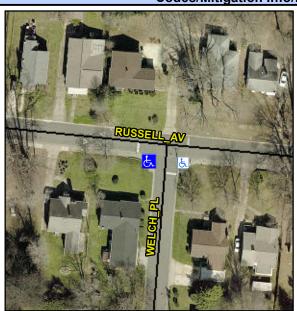
Surveyor Notes:
NO LT SW

PROW/ADA:
Not Found, R304.5.3

| Field Measurements/Component Compliance | | | | | | |
|---|---|---|---|---|---|---|
| | Yes | Ramp Width (in) | 71.0 | No | BlendTrans XSlope (%) | 6.2 |
| | | | | No | Curb Slope (%) | 23.1 |

Remove & Replace Curb Ramp With
Two New Directional Ramps or
Equivalent.
