Access Compliance Report Public Rights-of-Way (Curb Ramps)

Intersection ID: 14620 Main Street: EUCLID_AV Cross Street: MCDONALD_AV Location: N

ADA ID: 6078E06CD47E Ramp Type: Directional1 Initial Pass/Fail: Fail Overall Compliance: No Severity Score: 26.25

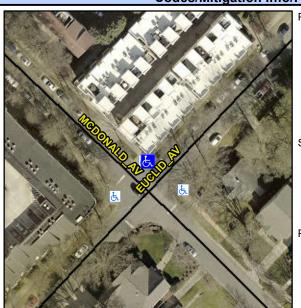
| Field Measurements/Component Compliance | | | | | |
|---|---|---|---|---|---|
| No | Ramp Slope (%) | 12.7 | N/A | Grade Break XSlope (%) | 0.0 |
| No | Ramp XSlope (%) | 3.2 | | | |
| N/A | Gutter Ponding? | Yes | N/A | Gutter Slope (%) | N/A |

Total Cost: \$ 1600.00
