Access Compliance Report

Public Rights-of-Way

(Curb Ramps)

Intersection ID: 30131	Main Street: WADENA_DR	Cross Street: HARLAND_ST	Location: SW
ADA ID: 607BAD53BC92	Ramp Type: PerpDiag	Initial Pass/Fail: Fail	Overall Compliance: No
Severity Score: 12.5			
Codes/Mitigation Info/Possible Solution		Field Measurements/Component Compliance

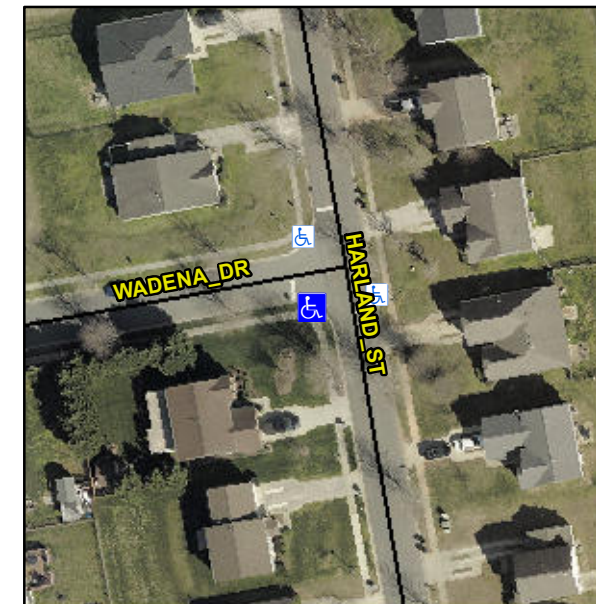
Not Found, R304.2.2

Compliance	Description	Data	Compliance	Description	Data
N/A	Ramp Length (in)	42.0	No	Ramp Slope (%)	8.6
Yes	Ramp Width (in)	48.0	Yes	Ramp XSlope (%)	1.6
N/A	Flare Type LT	N/A	N/A	Flare Type RT	N/A
N/A	Flare Slope LT (%)	N/A	N/A	Flare Slope RT (%)	N/A
N/A	Flare Traversable LT?	N/A	N/A	Flare Traversable RT?	N/A
N/A	Landing Length (in)	N/A	N/A	DWS Provided?	N/A
N/A	Landing Width (in)	N/A	N/A	DWS Contrast?	N/A
N/A	Landing Slope (%)	N/A	N/A	DWS Length (in)	N/A
N/A	Landing X Slope (%)	N/A	N/A	DWS Full Width?	N/A
N/A	Landing Curb? (Y/N)	N/A	N/A	DWS Offset (in)	N/A
N/A	Shared Landing?	N/A			
N/A	Gutter Ponding?	N/A	N/A	Gutter Slope (%)	N/A
N/A	Gutter Lip Ht (in)	N/A	N/A	Gutter X Slope (%)	N/A
N/A	Painted X Walk1?	No	N/A	Painted X Walk2?	No
	X Walk 1 Direction	To E		X Walk 2 Direction	To N
N/A	X Walk 1 Width (in)	N/A	N/A	X Walk 2 Width (in)	N/A
	X Walk 1 Slope (%)	1.4		X Walk 2 Slope (%)	2.8
	X Walk 1 X Slope (%)	0.8		X Walk 2 X Slope (%)	0.4

Remove & Replace Curb Ramp With Two New Directional Ramps or Equivalent.
