Access Compliance Report

Public Rights-of-Way

(Curb Ramps)

Intersection ID: 44309	Main Street: LINDA_VISTA_LN	Cross Street: OLIVIA_DIANE_LN	Location: SE
ADA ID: 60B465FF8E1C	Ramp Type: PerpDiag	Initial Pass/Fail: Fail	Overall Compliance: No
Severity Score: 10			
Codes/Mitigation Info/Possible Solution		Field Measurements/Component Compliance

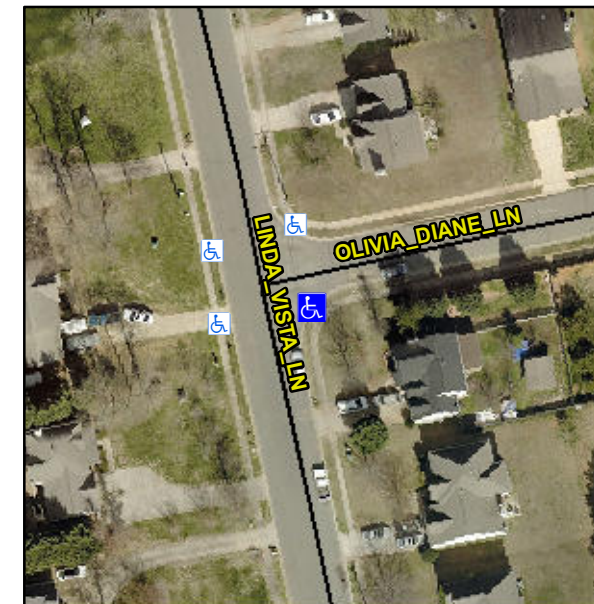
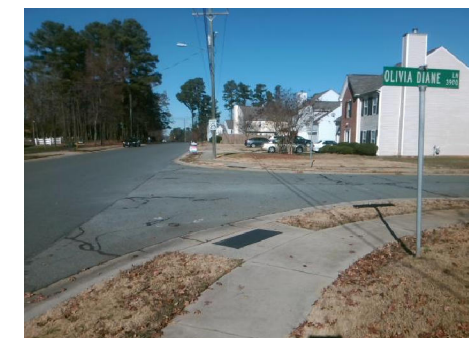
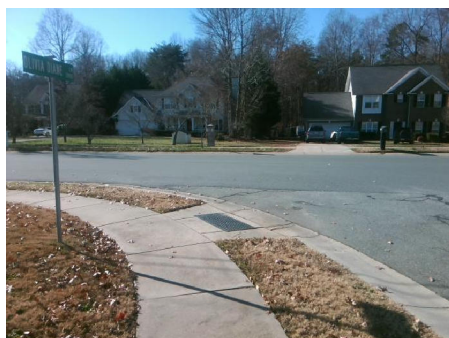
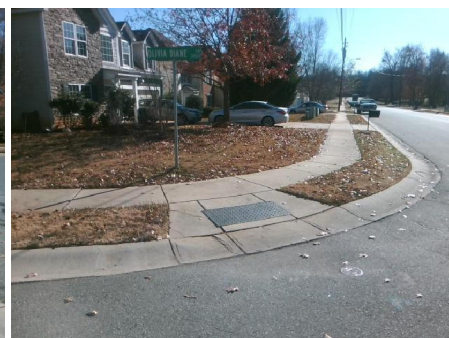
Not Found, R304.5.1, R304.5.3

Compliance	Description	Data	Compliance	Description	Data
N/A	Ramp Length (in)	47.5	Yes	Ramp Slope (%)	6.7
No	Ramp Width (in)	39.0	No	Ramp XSlope (%)	2.7
N/A	Flare Type LT	N/A	N/A	Flare Type RT	N/A
N/A	Flare Slope LT (%)	N/A	N/A	Flare Slope RT (%)	N/A
N/A	Flare Traversable LT?	N/A	N/A	Flare Traversable RT?	N/A
N/A	Landing Length (in)	N/A	N/A	DWS Provided?	N/A
N/A	Landing Width (in)	N/A	N/A	DWS Contrast?	N/A
N/A	Landing Slope (%)	N/A	N/A	DWS Length (in)	N/A
N/A	Landing X Slope (%)	N/A	N/A	DWS Full Width?	N/A
N/A	Landing Curb? (Y/N)	N/A	N/A	DWS Offset (in)	N/A
N/A	Shared Landing?	N/A			
N/A	Gutter Ponding?	N/A	N/A	Gutter Slope (%)	N/A
N/A	Gutter Lip Ht (in)	0.5	N/A	Gutter X Slope (%)	N/A
N/A	Painted X Walk1?	No	N/A	Painted X Walk2?	No
	X Walk 1 Direction	To N		X Walk 2 Direction	To W
N/A	X Walk 1 Width (in)	N/A	N/A	X Walk 2 Width (in)	N/A
	X Walk 1 Slope (%)	0.1		X Walk 2 Slope (%)	0.8
	X Walk 1 X Slope (%)	0.1		X Walk 2 X Slope (%)	0.6

N/A	Ramp inside XWalk1?	N/A	N/A	Ramp inside XWalk2?	N/A
	Road Slope (%)	2.9	N/A	Clear Space?	N/A
	Road X Slope (%)	3.2	N/A	Clear Space to XWalk (in)	N/A
N/A	Any Obstructions?	N/A	N/A	Storm Grate/Utility Hazard?	N/A
	Obstruction Type			Storm Grate/Utility Type	
		N/A			N/A
			Yes	Surface Condition? (G/P)	Good

Remove & Replace Curb Ramp With Two New Directional Ramps or Equivalent.
