## Access Compliance Report Public Rights-of-Way (Curb Ramps)

Intersection ID: 10490 Main Street: CREDENZA\_RD Cross Street: KARENDALE\_AV Location: E

ADA ID: 60C29B39C56C Ramp Type: Perp Initial Pass/Fail: Fail Overall Compliance: No Severity Score: 13.75

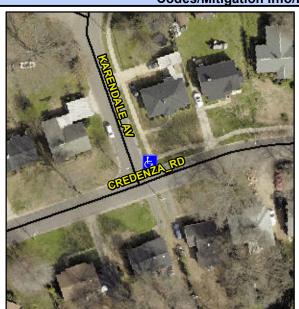
COSIDIC COIGHON	
Possible Solutions:	Cor
Remove & Replace Entire Ramp.	N/A
·	Yes
	N/A
	N/A
	N/A
	N/A
Surveyor Notes:	N/A
N/A	N/A
	N/A
	N/A
	N/A
PROW/ADA:	N/A
Not Found, R304.2.2	N/A
	N/A
	N/A
	N/A

Field Measurements/Component Compliance						
Comp	liance Description	Data	Comp	liance Description	Data	
N/A	Ramp Length (in)	78.0	No	Ramp Slope (%)	9.4	
Yes	Ramp Width (in)	48.5	Yes	Ramp XSlope (%)	3.0	
N/A	Flare Type LT	N/A	N/A	Flare Type RT	N/A	
N/A	Flare Slope LT (%)	N/A	N/A	Flare Slope RT (%)	N/A	
N/A	Flare Traversable LT?	N/A	N/A	Flare Traversable RT?	N/A	
N/A	Landing Length (in)	N/A	N/A	DWS Provided?	N/A	
N/A	Landing Width (in)	N/A	N/A	DWS Contrast?	N/A	
N/A	Landing Slope (%)	N/A	N/A	DWS Length (in)	N/A	
N/A	Landing X Slope (%)	N/A	N/A	DWS Full Width?	N/A	
N/A	Landing Curb? (Y/N)	N/A	N/A	DWS Offset (in)	N/A	
N/A	Shared Landing?	N/A				
N/A	Gutter Ponding?	N/A	N/A	Gutter Slope (%)	N/A	
N/A	Gutter Lip Ht (in)	N/A	N/A	Gutter X Slope (%)	N/A	
N/A	Painted X Walk1?	No	N/A	Painted X Walk2?	N/A	
	X Walk 1 Direction	To S		X Walk 2 Direction	N/A	
N/A	X Walk 1 Width (in)	N/A	N/A	X Walk 2 Width (in)	N/A	
	X Walk 1 Slope (%)	2.3		X Walk 2 Slope (%)	N/A
