Access Compliance Report

Public Rights-of-Way

| Intersection ID: 12482 | Main Street: SEAFORTH_DR | Cross Street: SUDBURY_RD | Location: SE |
| ADA ID: 617CEFB6DE63 | Ramp Type: Perp | Initial Pass/Fail: Fail | Overall Compliance: No |

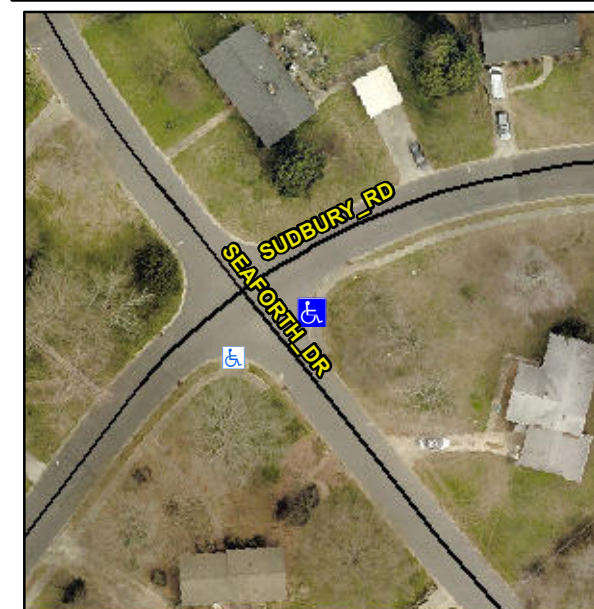
| Severity Score: 8.75 | | | |

Not Found, R304.5.1

| Compliance | Description | Data | Compliance | Description | Data |
|---|---|---|---|---|---|
| No | Ramp Width (in) | 44.5 | Yes | Ramp XSlope (%) | 1.1 |

Remove & Replace Entire Ramp.

Total Cost: \$ 1850.00
