Access Compliance Report Public Rights-of-Way (Curb Ramps)

Intersection ID: N/A Main Street: E_MARTIN_LUTHER_KING_JR_CBVss Street: S_COLLEGE_ST Location: Ε

ADA ID: 619A921AC04E Ramp Type: PerpDiag Initial Pass/Fail: Fail **Overall Compliance: No Severity Score:** 50

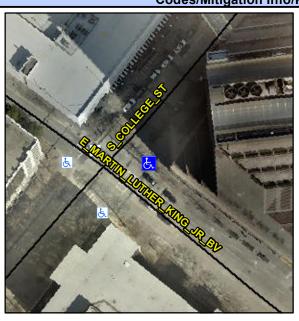
Field Measurements/Component Compliance						
Compliance Description			Data	Com	oliance Description	Data
N	/ A	Ramp Length (in)	72.0	No	Ramp Slope (%)	12.9
Ye	es	Ramp Width (in)	72.0	No	Ramp XSlope (%)	7.0
N	/A	Flare Type LT	N/A	N/A	Flare Type RT	N/A
N	/ A	Flare Slope LT (%)	N/A	N/A	Flare Slope RT (%)	N/A
N	/ A	Flare Traversable LT?	No	N/A	Flare Traversable RT?	No
N	/ A	Landing Length (in)	N/A	N/A	DWS Provided?	N/A
N	/ A	Landing Width (in)	N/A	N/A	DWS Contrast?	N/A
N	/ A	Landing Slope (%)	N/A	N/A	DWS Length (in)	N/A
N	/ A	Landing X Slope (%)	N/A	N/A	DWS Full Width?	N/A
N	/ A	Landing Curb? (Y/N)	N/A	N/A	DWS Offset (in)	N/A
N	/ A	Shared Landing?	N/A			
N	/ A	Gutter Ponding?	N/A	N/A	Gutter Slope (%)	N/A
N	/A	Gutter Lip Ht (in)	N/A	N/A	Gutter X Slope (%)	N/A
N	/ A	Painted X Walk1?	No	N/A	Painted X Walk2?	No
		X Walk 1 Direction	To NW		X Walk 2 Direction	To SW
N	/ A	X Walk 1 Width (in)	N/A	N/A	X Walk 2 Width (in)	N/A

X Walk 1 Slope (%)	6.4		X Walk 2 Slope (%)	2.4
		X Walk 1 X Slope (%)	6.2		X Walk 2 X Slope (%)	8.7
N	/ A	Ramp inside XWalk1?	N/A	N/A	Ramp inside XWalk2?	N/A
		Road Slope (%)	6.8	N/A	Clear Space?	N/A
		Road X Slope (%)	5.1	N/A	Clear Space to XWalk (in)	N/A
N	/ A	Any Obstructions?	N/A	N/A	Storm Grate/Utility Hazard?	N/A
		Obstruction Type		l	Storm Grate/Utility Type	
			N/A			N/A
				Yes	Surface Condition? (G/P)	Good

Possible Solutions: Remove & Replace Curb Ramp With **Two New Directional Ramps or** Equivalent. Surveyor Notes: N/A PROW/ADA: R304.2.2, R304.5.3
