Access Compliance Report

Public Rights-of-Way

(Curb Ramps)

| Intersection ID: 44910 | Main Street: FOX_POINT_DR | Cross Street: OAKBURN_DR | Location: SE |

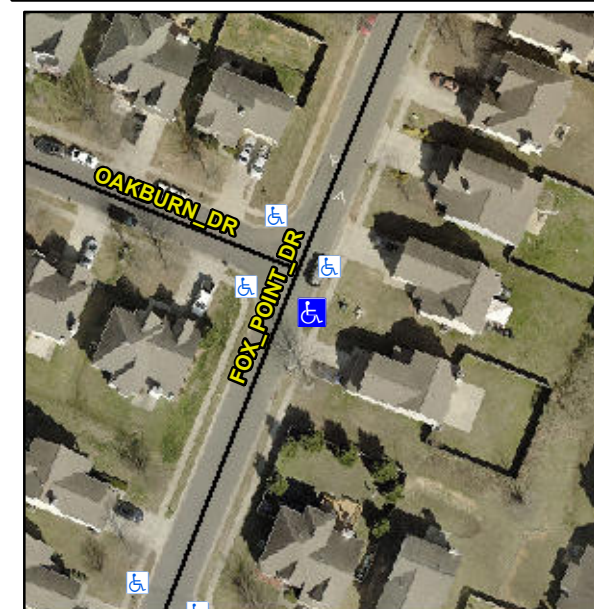
| ADA ID: 620DD3492E33 | Ramp Type: Perp | Initial Pass/Fail: Fail | Overall Compliance: No |
| Severity Score: 21.25 | | | |

Not Found, R304.5.1, R304.2.2

| Compliance | Description | Data | Compliance | Description | Data |
|---|---|---|---|---|---|
| N/A | Ramp Length (in) | 47.5 | No | Ramp Slope (%) | 10.5 |
| No | Ramp Width (in) | 46.5 | Yes | Ramp XSlope (%) | 1.1 |

Remove & Replace Entire Ramp.
