# Access Compliance Report

## Public Rights-of-Way

### (Curb Ramps)

Intersection ID: 30021	Main Street: DAY_LILLY_LN	Cross Street: SUMMER_MEADOW_CT	Location: SW
ADA ID: 621629CFC6CD	Ramp Type: Perp	Initial Pass/Fail: Fail	Overall Compliance: No
		Severity Score: 12.5

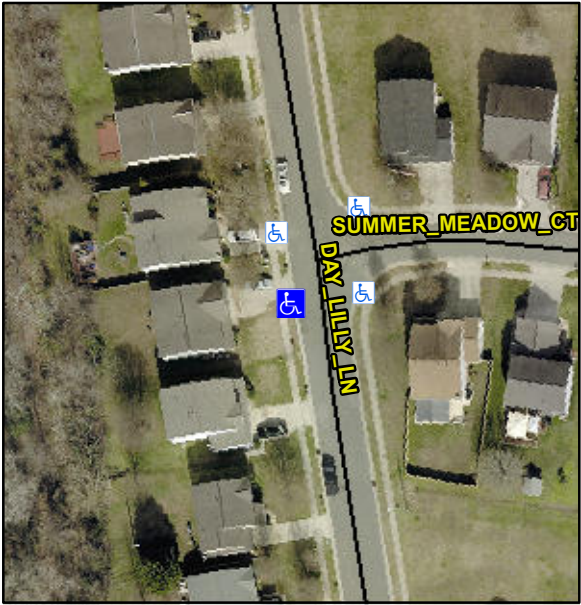
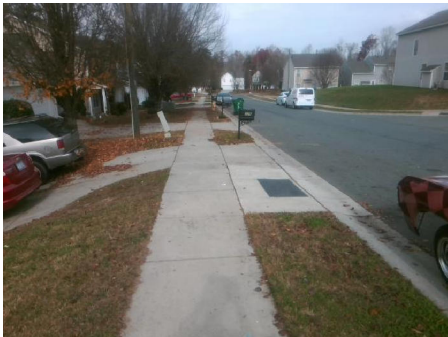
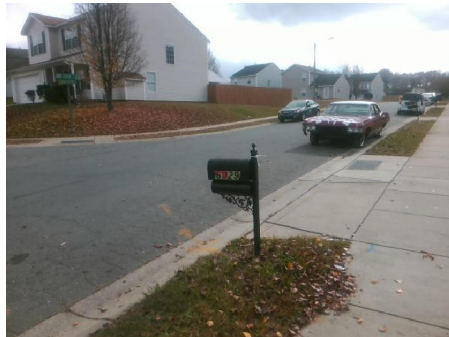
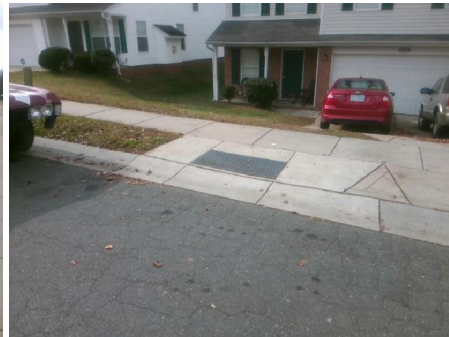
Compliance	Description	Data	Compliance	Description	Data
N/A	Ramp Length (in)	47.0	Yes	Ramp Slope (%)	6.6
Yes	Ramp Width (in)	48.0	No	Ramp XSlope (%)	5.1
N/A	Flare Type LT	N/A	N/A	Flare Type RT	N/A
N/A	Flare Slope LT (%)	N/A	N/A	Flare Slope RT (%)	N/A
N/A	Flare Traversable LT?	N/A	N/A	Flare Traversable RT?	N/A
N/A	Landing Length (in)	N/A	N/A	DWS Provided?	N/A
N/A	Landing Width (in)	N/A	N/A	DWS Contrast?	N/A
N/A	Landing Slope (%)	N/A	N/A	DWS Length (in)	N/A
N/A	Landing X Slope (%)	N/A	N/A	DWS Full Width?	N/A
N/A	Landing Curb? (Y/N)	N/A	N/A	DWS Offset (in)	N/A
N/A	Shared Landing?	N/A			
N/A	Gutter Ponding?	N/A	N/A	Gutter Slope (%)	N/A
N/A	Gutter Lip Ht (in)	N/A	N/A	Gutter X Slope (%)	N/A
N/A	Painted X Walk1?	No	N/A	Painted X Walk2?	N/A
	X Walk 1 Direction	To E		X Walk 2 Direction	N/A
N/A	X Walk 1 Width (in)	N/A	N/A	X Walk 2 Width (in)	N/A
	X Walk 1 Slope (%)	2.8		X Walk 2 Slope (%)	N/A
	X Walk 1 X Slope (%)	4.3		X Walk 2 X Slope (%)	N/A

N/A	Ramp inside XWalk1?	N/A	N/A	Ramp inside XWalk2?	N/A
	Road Slope (%)	N/A	N/A	Clear Space?	N/A
	Road X Slope (%)	N/A	N/A	Clear Space to XWalk (in)	N/A
N/A	Any Obstructions?	N/A	N/A	Storm Grate/Utility Hazard?	N/A
	Obstruction Type			Storm Grate/Utility Type	
		N/A			N/A
			Yes	Surface Condition? (G/P)	Good

Possible Solutions:	<b>Remove &amp; Replace Entire Ramp.</b>					
	Surveyor Notes:	<b>N/A</b>					
	PROW/ADA:	<b>Not Found, R304.5.3</b>					
Street 1 Name	DAY LILLY LN						
Stop Condition-Street 2	None						
Street 2 Name	N/A						
Stop Condition-Street 1	N/A						
Total Cost:		\$	1850.00
