# Access Compliance Report

## Public Rights-of-Way

### (Curb Ramps)

Intersection ID: N/A	Main Street: FIRST_RUN_CT	Cross Street: MONARCH_BIRCH_LN	Location: E
ADA ID: 62612FBF383D	Ramp Type: Combination2Diag	Initial Pass/Fail: Fail	Overall Compliance: No
		Severity Score: 0

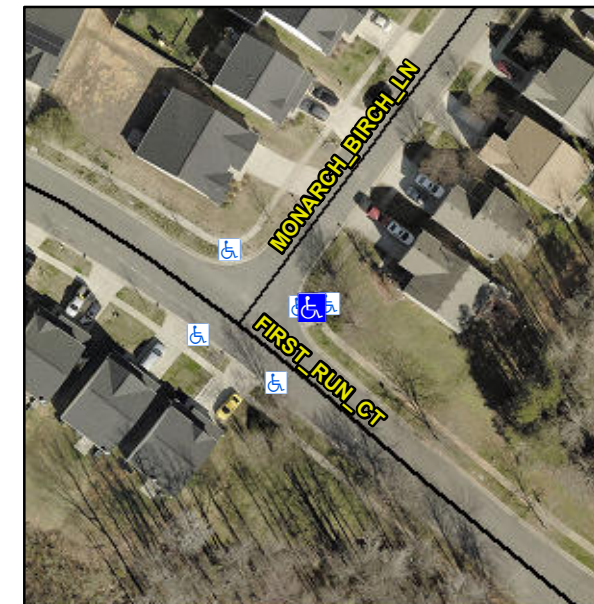
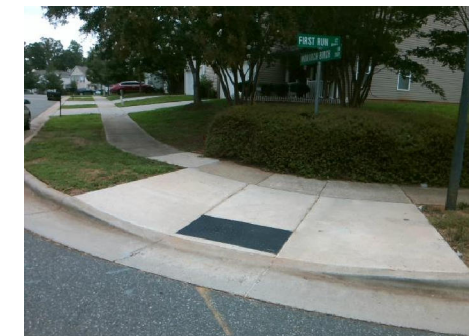
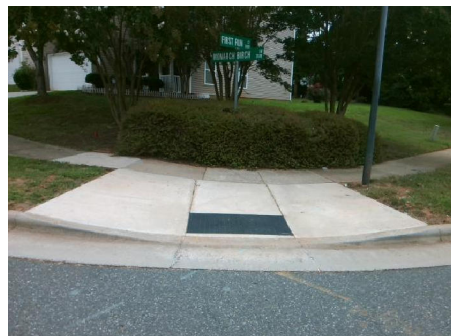
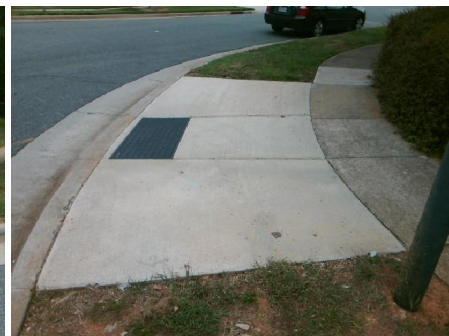
**Not Found, R304.5.1, R304.5.1, R304.5.3, R304.3.2**

Compliance	Description	Data	Compliance	Description	Data
N/A	Ramp Length LT (in)	55.5	N/A	Ramp Length RT (in)	53.0
No	Ramp Width LT (in)	47.0	No	Ramp Width RT (in)	47.0
No	Ramp Slope LT (%)	9.0	Yes	Ramp Slope RT (%)	1.4
No	Ramp XSlope LT (%)	5.8	No	Ramp XSlope RT (%)	5.0
N/A	Ramp Length (in)	86.5	Yes	Ramp Slope (%)	7.0
No	Ramp Width (in)	46.5	No	Ramp XSlope (%)	4.7
N/A	Flare Type LT	N/A	N/A	Flare Type RT	N/A
N/A	Flare Slope LT (%)	N/A	N/A	Flare Slope RT (%)	N/A
N/A	Flare Traversable LT?	N/A	N/A	Flare Traversable RT?	N/A
N/A	Landing Length (in)	N/A	N/A	DWS Provided?	N/A
N/A	Landing Width (in)	N/A	N/A	DWS Contrast?	N/A
N/A	Landing Slope (%)	N/A	N/A	DWS Length (in)	N/A
N/A	Landing X Slope (%)	N/A	N/A	DWS Full Width?	N/A
N/A	Landing Curb? (Y/N)	N/A	N/A	DWS Offset (in)	N/A
N/A	Shared Landing?	N/A			
N/A	Gutter Ponding?	N/A	N/A	Gutter Slope (%)	N/A
N/A	Gutter Lip Ht (in)	N/A	N/A	Gutter X Slope (%)	N/A
N/A	Painted X Walk1?	No	N/A	Painted X Walk2?	No

**Remove & Replace Curb Ramp With Two New Directional Ramps or Equivalent.**
