Access Compliance Report

Public Rights-of-Way

(Curb Ramps)

Intersection ID: 2731	Main Street: TANAGER_LN	Cross Street: VIREO_CT	Location: NW
ADA ID: 62749CE7FDCC	Ramp Type: Perp	Initial Pass/Fail: Fail	Overall Compliance: No
Severity Score: 22.5			
Codes/Mitigation Info/Possible Solution		Field Measurements/Component Compliance

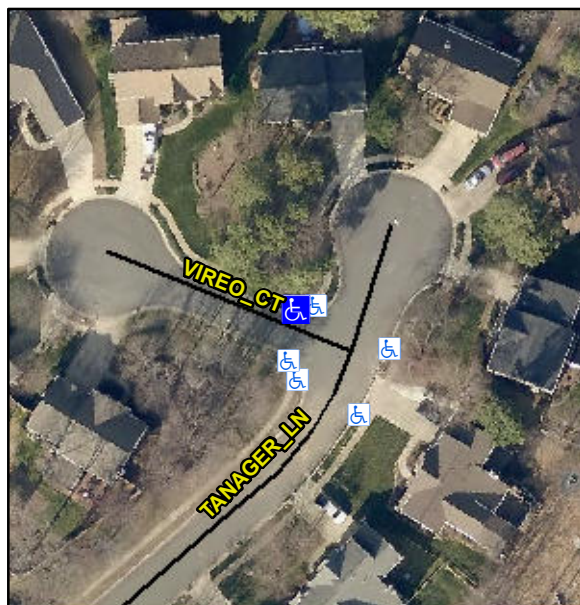
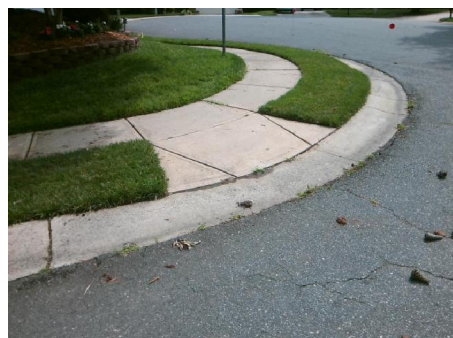
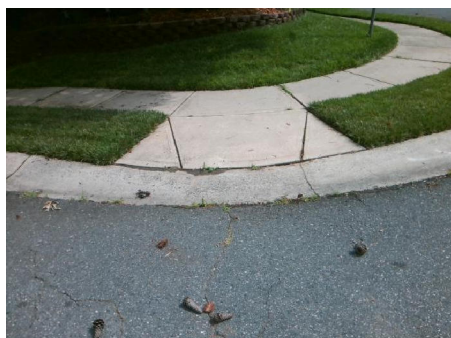
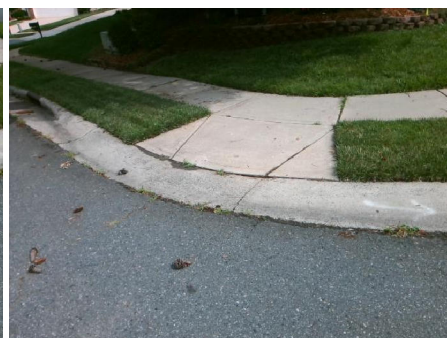
R304.5.1, R304.2.2, R304.5.3

Compliance	Description	Data	Compliance	Description	Data
N/A	Ramp Length (in)	49.0	No	Ramp Slope (%)	8.4
No	Ramp Width (in)	44.0	No	Ramp XSlope (%)	3.2
N/A	Flare Type LT	N/A	N/A	Flare Type RT	N/A
N/A	Flare Slope LT (%)	N/A	N/A	Flare Slope RT (%)	N/A
N/A	Flare Traversable LT?	N/A	N/A	Flare Traversable RT?	N/A
N/A	Landing Length (in)	N/A	N/A	DWS Provided?	N/A
N/A	Landing Width (in)	N/A	N/A	DWS Contrast?	N/A
N/A	Landing Slope (%)	N/A	N/A	DWS Length (in)	N/A
N/A	Landing X Slope (%)	N/A	N/A	DWS Full Width?	N/A
N/A	Landing Curb? (Y/N)	N/A	N/A	DWS Offset (in)	N/A
N/A	Shared Landing?	N/A			
N/A	Gutter Ponding?	N/A	N/A	Gutter Slope (%)	N/A
N/A	Gutter Lip Ht (in)	1.0	N/A	Gutter X Slope (%)	N/A
N/A	Painted X Walk1?	No	N/A	Painted X Walk2?	N/A
	X Walk 1 Direction	To SW		X Walk 2 Direction	N/A
N/A	X Walk 1 Width (in)	N/A	N/A	X Walk 2 Width (in)	N/A
	X Walk 1 Slope (%)	4.6		X Walk 2 Slope (%)	N/A
	X Walk 1 X Slope (%)	5.6		X Walk 2 X Slope (%)	N/A

N/A	Ramp inside XWalk1?	N/A	N/A	Ramp inside XWalk2?	N/A
	Road Slope (%)	N/A	N/A	Clear Space?	N/A
	Road X Slope (%)	N/A	N/A	Clear Space to XWalk (in)	N/A
N/A	Any Obstructions?	N/A	N/A	Storm Grate/Utility Hazard?	N/A
	Obstruction Type			Storm Grate/Utility Type	
		N/A			N/A
			Yes	Surface Condition? (G/P)	Good

Remove & Replace Entire Ramp.
