Access Compliance Report Public Rights-of-Way (Curb Ramps)

Intersection ID: 44922 Main Street: MAPLE_PARK_LN Cross Street: ROBUR_CT Location: SW

ADA ID: 62A8C52BA538 Ramp Type: PerpDiag Initial Pass/Fail: Fail Overall Compliance: No Severity Score: 17.5

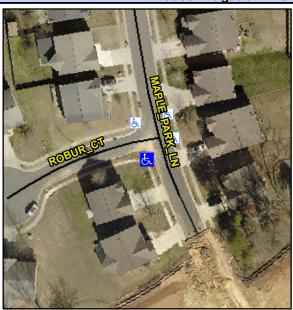
Not Found, R304.5.1

Fleid Measurements/Component Compliance					
Compliance Description		Data	Compliance Description		Data
N/A	Ramp Length (in)	50.0	Yes	Ramp Slope (%)	5.1
No	Ramp Width (in)	35.0	Yes	Ramp XSlope (%)	1.5
N/A	Flare Type LT	N/A	N/A	Flare Type RT	N/A
N/A	Flare Slope LT (%)	N/A	N/A	Flare Slope RT (%)	N/A
N/A	Flare Traversable LT?	N/A	N/A	Flare Traversable RT?	N/A
N/A	Landing Length (in)	N/A	N/A	DWS Provided?	N/A
N/A	Landing Width (in)	N/A	N/A	DWS Contrast?	N/A
N/A	Landing Slope (%)	N/A	N/A	DWS Length (in)	N/A
N/A	Landing X Slope (%)	N/A	N/A	DWS Full Width?	N/A
N/A	Landing Curb? (Y/N)	N/A	N/A	DWS Offset (in)	N/A
N/A	Shared Landing?	N/A			
N/A	Gutter Ponding?	N/A	N/A	Gutter Slope (%)	N/A
N/A	Gutter Lip Ht (in)	N/A	N/A	Gutter X Slope (%)	N/A
N/A	Painted X Walk1?	No	N/A	Painted X Walk2?	No
	X Walk 1 Direction	То Е		X Walk 2 Direction	To N
N/A	X Walk 1 Width (in)	N/A	N/A	X Walk 2 Width (in)	N/A
	X Walk 1 Slope (%)	1.2		X Walk 2 Slope (%)	0.3

Remove & Replace Curb Ramp With
Two New Directional Ramps or
Equivalent.
