Access Compliance Report

Public Rights-of-Way

| Intersection ID: 17902 | Main Street: MONROE_RD | Cross Street: CONFERENCE_DR | Location: SE |
| ADA ID: 63AEEF218143 | Ramp Type: Perp | Initial Pass/Fail: Fail | Overall Compliance: No |

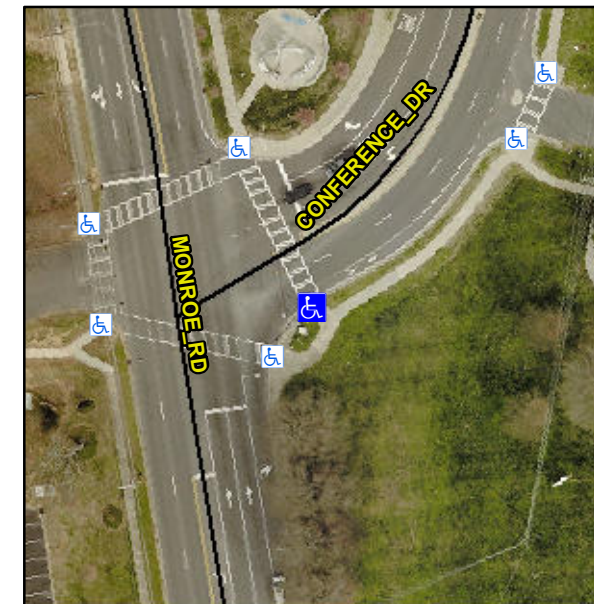
| Severity Score: 25 | | | |

Not Found, R304.2.2, R304.5.3

| Compliance | Description | Data | Compliance | Description | Data |
|---|---|---|---|---|---|
| N/A | Ramp Length (in) | 52.0 | No | Ramp Slope (%) | 11.5 |
| Yes | Ramp Width (in) | 48.0 | No | Ramp XSlope (%) | 5.8 |

Remove & Replace Entire Ramp.
