Access Compliance Report

Public Rights-of-Way

| Intersection ID: 44057 | Main Street: HOLLAND_PARK_LN | Cross Street: LONGSTONE_LN | Location: E |
| ADA ID: 6418020F2756 | Ramp Type: PerpDiag | Initial Pass/Fail: Fail | Overall Compliance: No |

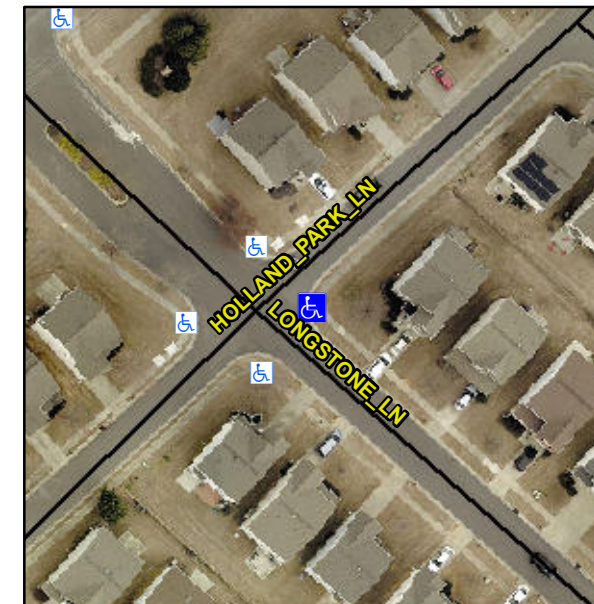
| | | | Severity Score: 33.75 |

Not Found, R304.5.1, R304.5.3

| Compliance | Description | Data | Compliance | Description | Data |
|---|---|---|---|---|---|
| No | Ramp Width (in) | 37.5 | No | Ramp XSlope (%) | 11.5 |

Remove & Replace Curb Ramp With Two New Directional Ramps or Equivalent.
