Access Compliance Report

Public Rights-of-Way

(Curb Ramps)

Intersection ID: 50539	Main Street: CAYENNE_DR	Cross Street: MT_HOLLY-HUNTERSVILLE_RD	Location: SE
ADA ID: 648A1F80C97B	Ramp Type: Combination1	Initial Pass/Fail: Fail	Overall Compliance: No
Codes/Mitigation Info/Possible Solution		Field Measurements/Component Compliance	
Severity Score: 8.75

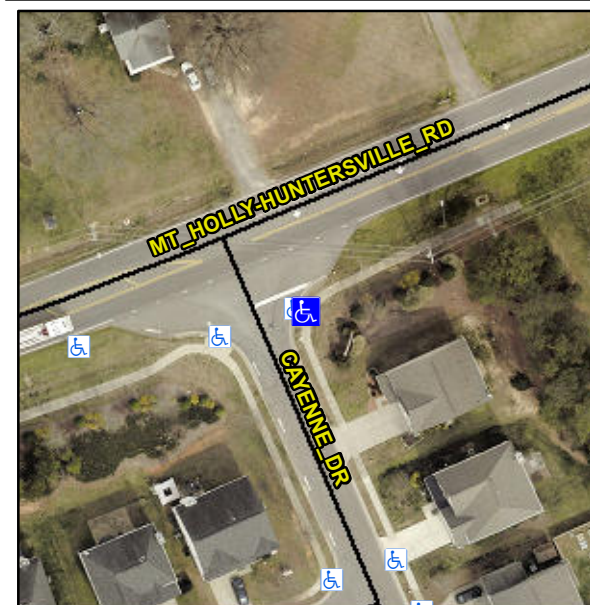
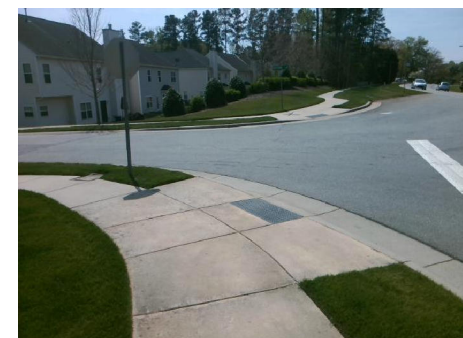
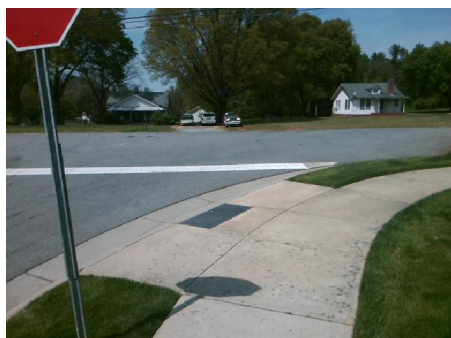
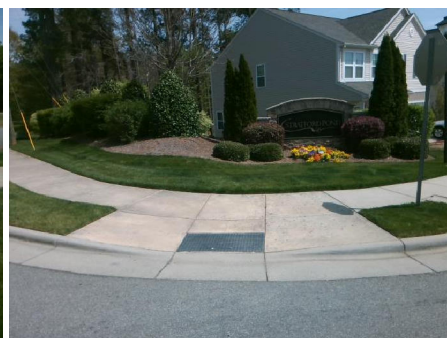
LT RP < 5%, RT RP < 5%

Not Found, R304.5.1

Remove & Replace Entire Ramp.
