Access Compliance Report

Public Rights-of-Way

(Curb Ramps)

Intersection ID: 13612	Main Street: MORNINGSIDE_DR	Cross Street: LYON_CT	Location: SW
ADA ID: 64A86E3C4F66	Ramp Type: Perp	Initial Pass/Fail: Fail	Overall Compliance: No
		Severity Score: 22.5

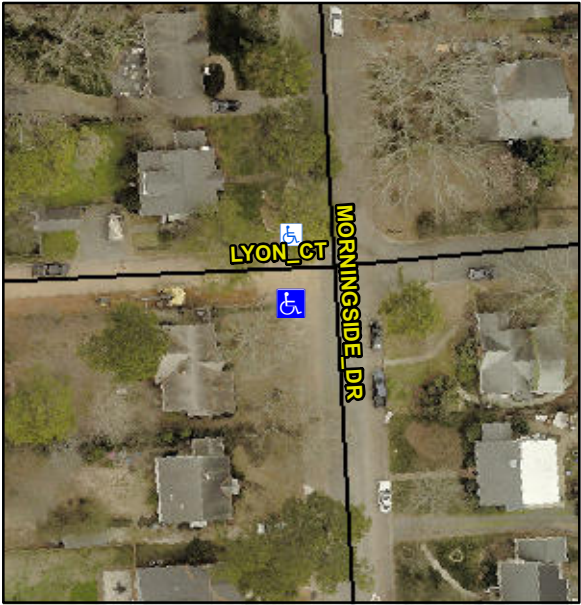
Possible Solutions:		Compliance	Description	Data
	Remove & Replace Entire Ramp.		No	Ramp Length (in)	60.0
			No	Ramp Width (in)	40.0
			N/A	Flare Type LT	N/A
			N/A	Flare Slope LT (%)	N/A
			N/A	Flare Traversable LT?	N/A
			N/A	Landing Length (in)	N/A
			N/A	Landing Width (in)	N/A
			N/A	Landing Slope (%)	N/A
			N/A	Landing X Slope (%)	N/A
<p>Surveyor Notes:</p> <p>N/A</p> <p>PROW/ADA:</p> <p>R304.5.1, R304.2.2, R304.5.3</p>			N/A	Flare Type RT	N/A
			N/A	Flare Slope RT (%)	N/A
			N/A	Flare Traversable RT?	N/A
			N/A	DWS Provided?	N/A
			N/A	DWS Contrast?	N/A
			N/A	DWS Length (in)	N/A
			N/A	DWS Full Width?	N/A
			N/A	DWS Offset (in)	N/A
			N/A	Gutter Ponding?	N/A
			N/A	Gutter Lip Ht (in)	3.0
			No	Painted X Walk1?	N/A
				X Walk 1 Direction	To N
			N/A	X Walk 1 Width (in)	N/A
				X Walk 1 Slope (%)	5.6
				X Walk 1 X Slope (%)	0.2
