Access Compliance Report Public Rights-of-Way (Curb Ramps)

Intersection ID: 48421 Main Street: EVANTON LOCH RD **Cross Street: CULLEN CT** Location: SW **Overall Compliance: No** ADA ID: 64A9C6DF087C Ramp Type: PerpDiag Initial Pass/Fail: Fail **Severity Score:** 12.5

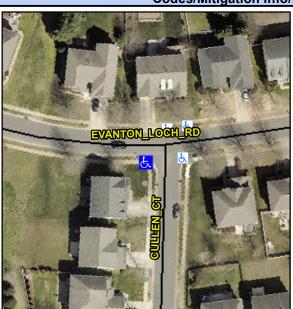
Comp	liance Description	Data	Comp	Data	
N/A	Ramp Length (in)	47.0	No	Ramp Slope (%)	8.8
Yes	Ramp Width (in)	48.0	Yes	Ramp XSlope (%)	0.4
N/A	Flare Type LT	N/A	N/A	Flare Type RT	N/A
N/A	Flare Slope LT (%)	N/A	N/A	Flare Slope RT (%)	N/A
N/A	Flare Traversable LT?	N/A	N/A	Flare Traversable RT?	N/A
N/A	Landing Length (in)	N/A	N/A	DWS Provided?	N/A
N/A	Landing Width (in)	N/A	N/A	DWS Contrast?	N/A
N/A	Landing Slope (%)	N/A	N/A	DWS Length (in)	N/A
N/A	Landing X Slope (%)	N/A	N/A	DWS Full Width?	N/A
N/A	Landing Curb? (Y/N)	N/A	N/A	DWS Offset (in)	N/A
N/A	Shared Landing?	N/A			
N/A	Gutter Ponding?	N/A	N/A	Gutter Slope (%)	N/A
N/A	Gutter Lip Ht (in)	N/A	N/A	Gutter X Slope (%)	N/A
N/A	Painted X Walk1?	No	N/A	Painted X Walk2?	No
	X Walk 1 Direction	To E		X Walk 2 Direction	To N
N/A	X Walk 1 Width (in)	N/A	N/A	X Walk 2 Width (in)	N/A
	X Walk 1 Slope (%)	0.7		X Walk 2 Slope (%)	4.2
	X Walk 1 X Slope (%)	1.6		X Walk 2 X Slope (%)	0.1

Possible Solution
Possible Solutions:
Remove & Replace Curb Ramp With Two New Directional Ramps or Equivalent.
Surveyor Notes:
N/A
PROW/ADA:
R304.2.2
