## Access Compliance Report Public Rights-of-Way (Curb Ramps)

Intersection ID: 12918Main Street:CLEMENT\_AVCross Street:HAMORTON\_PLLocation:NEADA ID: 64F6B436DAC0Ramp Type:PerpendicularInitial Pass/Fail:FailOverall Compliance:NoSeverity Score:10

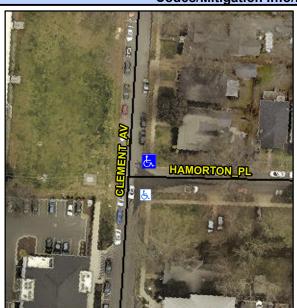
Field Measurements/Component Compliance						
Compl	iance Description	Data	Comp	liance Description	Data	
N/A	Ramp Length (in)	60.0	Yes	Ramp Slope (%)	6.9	
No	Ramp Width (in)	47.0	No	Ramp XSlope (%)	2.1	
N/A	Flare Type LT	N/A	N/A	Flare Type RT	N/A	
N/A	Flare Slope LT (%)	N/A	N/A	Flare Slope RT (%)	N/A	
N/A	Flare Traversable LT?	N/A	N/A	Flare Traversable RT?	N/A	
N/A	Landing Length (in)	N/A	N/A	DWS Provided?	N/A	
N/A	Landing Width (in)	N/A	N/A	DWS Contrast?	N/A	
N/A	Landing Slope (%)	N/A	N/A	DWS Length (in)	N/A	
N/A	Landing X Slope (%)	N/A	N/A	DWS Full Width?	N/A	
N/A	Landing Curb? (Y/N)	N/A	N/A	DWS Offset (in)	N/A	
N/A	Shared Landing?	N/A				
N/A	Gutter Ponding?	N/A	N/A	Gutter Slope (%)	N/A	
N/A	Gutter Lip Ht (in)	0.5	N/A	Gutter X Slope (%)	N/A	
N/A	Painted X Walk1?	No	N/A	Painted X Walk2?	N/A	
	X Walk 1 Direction	To S		X Walk 2 Direction	N/A	
N/A	X Walk 1 Width (in)	N/A	N/A	X Walk 2 Width (in)	N/A	
	X Walk 1 Slope (%)	1.8		X Walk 2 Slope (%)	N/A

X Walk 1 X Slope (%)	2.2		X Walk 2 X Slope (%)	N/A	
N/A	Ramp inside XWalk1?	N/A	N/A	Ramp inside XWalk2?	N/A	
	Road Slope (%)	N/A	N/A	Clear Space?	N/A	
	Road X Slope (%)	N/A	N/A	Clear Space to XWalk (in)	N/A	
N/A	Any Obstructions?	N/A	N/A	Storm Grate/Utility Hazard?	N/A	
	Obstruction Type			Storm Grate/Utility Type		
		N/A			N/A	
7 20			Yes	Surface Condition? (G/P)	Good

n ossible solution		
Possible Solutions:	Comp	lianc
Remove & Replace Entire Ramp.	N/A	Ra
	No	Ra
	N/A	Fla
	N/A	Fla
	N/A	Fla
	N/A	La
Surveyor Notes:	N/A	La
N/A	N/A	La
	N/A	La
	N/A	La
	N/A	Sh
PROW/ADA:	N/A	Gι
Not Found, R304.5.1, R304.5.3	N/A	Gι
	N/A	Pa
		X١
	N/A	X١
		X١
		X١
	N/A	Ra
		Ro
		Ro
