Access Compliance Report Public Rights-of-Way (Curb Ramps)

Intersection ID: 51478 Main Street: BENDERLOCH_DR Cross Street: MEADOW_BOTTOM_RD Location: N

ADA ID: 6523D9D1DD3A Ramp Type: Perpendicular Initial Pass/Fail: Fail Overall Compliance: No Severity Score: 12.5

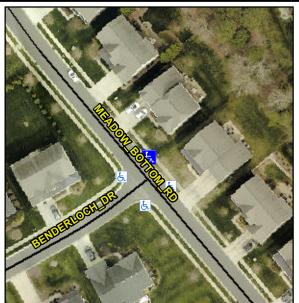
Not Found, R304.2.2

Field Measurements/Component Compilance					
Compliance Description D		Data	Comp	liance Description	Data
N/A	Ramp Length (in)	50.0	No	Ramp Slope (%)	9.6
Yes	Ramp Width (in)	48.0	Yes	Ramp XSlope (%)	0.0
N/A	Flare Type LT	N/A	N/A	Flare Type RT	N/A
N/A	Flare Slope LT (%)	N/A	N/A	Flare Slope RT (%)	N/A
N/A	Flare Traversable LT?	N/A	N/A	Flare Traversable RT?	N/A
N/A	Landing Length (in)	N/A	N/A	DWS Provided?	N/A
N/A	Landing Width (in)	N/A	N/A	DWS Contrast?	N/A
N/A	Landing Slope (%)	N/A	N/A	DWS Length (in)	N/A
N/A	Landing X Slope (%)	N/A	N/A	DWS Full Width?	N/A
N/A	Landing Curb? (Y/N)	N/A	N/A	DWS Offset (in)	N/A
N/A	Shared Landing?	N/A			
N/A	Gutter Ponding?	N/A	N/A	Gutter Slope (%)	N/A
N/A	Gutter Lip Ht (in)	N/A	N/A	Gutter X Slope (%)	N/A
N/A	Painted X Walk1?	No	N/A	Painted X Walk2?	N/A
	X Walk 1 Direction	To SW		X Walk 2 Direction	N/A
N/A	X Walk 1 Width (in)	N/A	N/A	X Walk 2 Width (in)	N/A
	X Walk 1 Slope (%)	0.6		X Walk 2 Slope (%)	N/A

Remove & Replace Entire Ramp.
