Access Compliance Report

Public Rights-of-Way

(Curb Ramps)

Intersection ID: 6727	Main Street: MILAN_RD_EAST	Cross Street: BRADEN_DR	Location: S
ADA ID: 6570FEBA64E8	Ramp Type: Perpendicular	Initial Pass/Fail: Fail	Overall Compliance: No
		Severity Score: 25

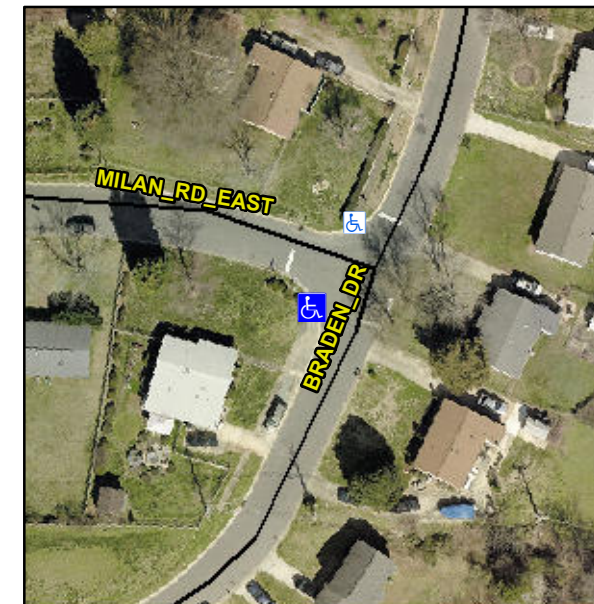
Not Found, R304.5.3

Compliance	Description	Data	Compliance	Description	Data
N/A	Ramp Length (in)	38.0	Yes	Ramp Slope (%)	8.1
Yes	Ramp Width (in)	48.0	No	Ramp XSlope (%)	14.1
N/A	Flare Type LT	N/A	N/A	Flare Type RT	N/A
N/A	Flare Slope LT (%)	N/A	N/A	Flare Slope RT (%)	N/A
N/A	Flare Traversable LT?	N/A	N/A	Flare Traversable RT?	N/A
N/A	Landing Length (in)	N/A	N/A	DWS Provided?	N/A
N/A	Landing Width (in)	N/A	N/A	DWS Contrast?	N/A
N/A	Landing Slope (%)	N/A	N/A	DWS Length (in)	N/A
N/A	Landing X Slope (%)	N/A	N/A	DWS Full Width?	N/A
N/A	Landing Curb? (Y/N)	N/A	N/A	DWS Offset (in)	N/A
N/A	Shared Landing?	N/A			
N/A	Gutter Ponding?	N/A	N/A	Gutter Slope (%)	N/A
N/A	Gutter Lip Ht (in)	N/A	N/A	Gutter X Slope (%)	N/A
N/A	Painted X Walk1?	No	N/A	Painted X Walk2?	N/A
	X Walk 1 Direction	To NE		X Walk 2 Direction	N/A
N/A	X Walk 1 Width (in)	N/A	N/A	X Walk 2 Width (in)	N/A
	X Walk 1 Slope (%)	11.6		X Walk 2 Slope (%)	N/A
	X Walk 1 X Slope (%)	1.5		X Walk 2 X Slope (%)	N/A

Remove & Replace Entire Ramp.
