# Access Compliance Report

## Public Rights-of-Way

### (Curb Ramps)

| Intersection ID: 8757 | | Main Street: JENNINGS_ST | | Cross Street: NEWCASTLE_ST | | Location: S | | | | | | | | | | | |

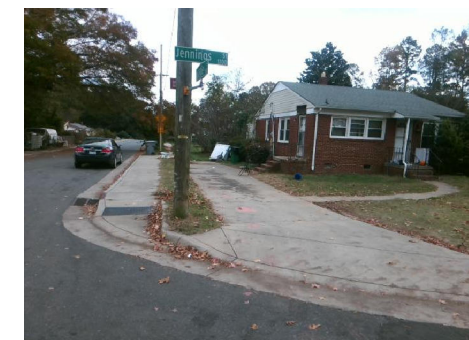
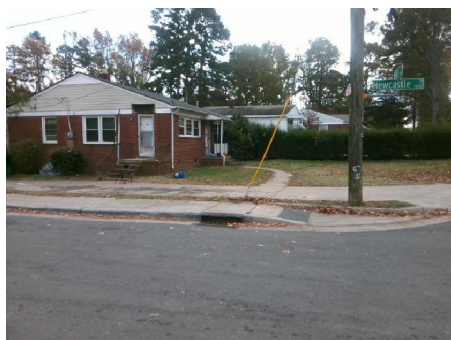
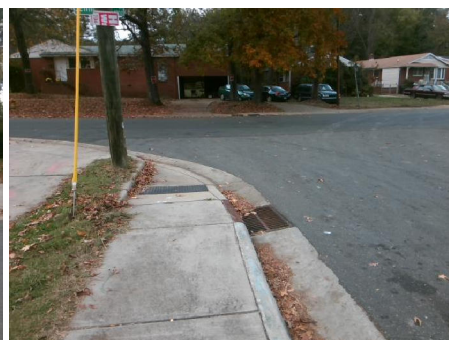
| | | | | | | No | Landing Length (in) | 37.0 | | Yes | DWS Provided? | Yes | | | | | |
| N/A | Shared Landing? | No | | | | No | DWS Offset RT (in) | 80.0 | | | | | | | | | |
| Yes | Gutter Lip Ht (in) | 0.0 | | | | No | Gutter X Slope (%) | 2.5 | | | | | | | | | |
| PROW/ADA:<br><br>Not Found, R304.2.1, R305.2, R304.5.3 | | N/A | Painted X Walk1? | No | | | Road Slope (%) | 5.6 | | | | | | | | | |

| | | | | Remove & Replace Entire Ramp.<br>Remove & Replace Gutter. | | N/A | Ramp Length (in) | 49.5 | | Yes | Grade Break? | Yes | | | | | |
