Access Compliance Report

Public Rights-of-Way

(Curb Ramps)

Intersection ID: 14023	Main Street: NORWICH_PL	Cross Street: CHELVESTON_DR	Location: SW
ADA ID: 65B17575F056	Ramp Type: Combination2Diag	Initial Pass/Fail: Pass	Overall Compliance: No
		Severity Score: 2.5

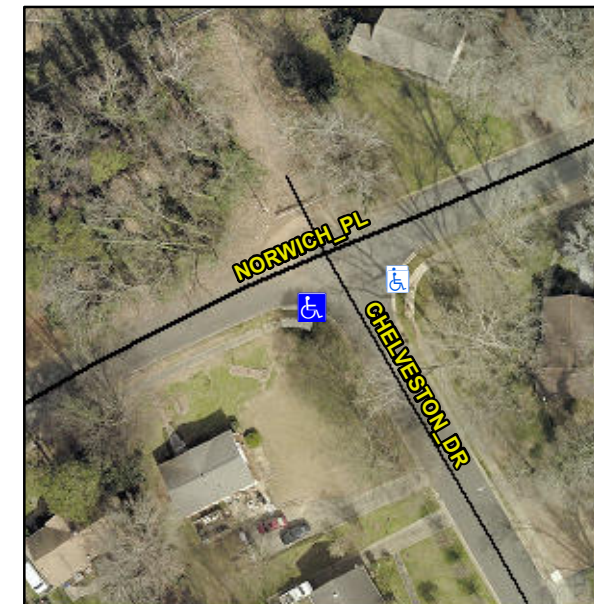
DWS WARPED

Not Found, R304.5.3, R305.1.4

Compliance	Description	Data	Compliance	Description	Data
N/A	Ramp Length LT (in)	N/A	N/A	Ramp Length RT (in)	118.0
N/A	Ramp Width LT (in)	N/A	Yes	Ramp Width RT (in)	59.0
N/A	Ramp Slope LT (%)	N/A	Yes	Ramp Slope RT (%)	7.4
N/A	Ramp XSlope LT (%)	N/A	No	Ramp XSlope RT (%)	4.4
N/A	Ramp Length (in)	59.0	Yes	Ramp Slope (%)	6.6
Yes	Ramp Width (in)	58.0	Yes	Ramp XSlope (%)	1.9
Yes	Flare Type L	Curbed_NoWalkSurface	Yes	Flare Type R	Curbed_NoWalkSurface
N/A	Flare Slope LT (%)	N/A	N/A	Flare Slope RT (%)	N/A
N/A	Flare Traversable LT?	No	N/A	Flare Traversable RT?	No
Yes	Landing Length (in)	59.0	Yes	DWS Provided?	Yes
Yes	Landing Width (in)	69.0	Yes	DWS Contrast?	Yes
Yes	Landing Slope (%)	1.2	Yes	DWS Length (in)	24.0
Yes	Landing X Slope (%)	1.4	No	DWS Full Width?	No
N/A	Landing Curb? (Y/N)	No	Yes	DWS Offset (in)	0.0
N/A	Shared Landing?	Yes			
Yes	Gutter Ponding?	No	Yes	Gutter Slope (%)	1.7
Yes	Gutter Lip Ht (in)	0.0	No	Gutter X Slope (%)	2.1

Remove & Replace Curb Ramp With Two New Directional Ramps or Equivalent. Remove & Replace Gutter.
