## Access Compliance Report Public Rights-of-Way (Curb Ramps)

Intersection ID: 11266 Main Street: AXAR\_RD Cross Street: MULBERRY\_CHURCH\_RD Location: SE

ADA ID: 676A557C898B Ramp Type: Perp Initial Pass/Fail: Fail Overall Compliance: No Severity Score: 21.25

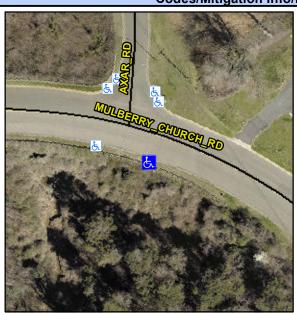
Field Measurements/Component Compliance						
Comp	liance Description	Data	Comp	liance Description	Data	
N/A	Ramp Length (in)	65.0	No	Ramp Slope (%)	9.3	
No	Ramp Width (in)	36.0	Yes	Ramp XSlope (%)	0.1	
N/A	Flare Type LT	N/A	N/A	Flare Type RT	N/A	
N/A	Flare Slope LT (%)	N/A	N/A	Flare Slope RT (%)	N/A	
N/A	Flare Traversable LT?	N/A	N/A	Flare Traversable RT?	N/A	
N/A	Landing Length (in)	N/A	N/A	DWS Provided?	N/A	
N/A	Landing Width (in)	N/A	N/A	DWS Contrast?	N/A	
N/A	Landing Slope (%)	N/A	N/A	DWS Length (in)	N/A	
N/A	Landing X Slope (%)	N/A	N/A	DWS Full Width?	N/A	
N/A	Landing Curb? (Y/N)	N/A	N/A	DWS Offset (in)	N/A	
N/A	Shared Landing?	N/A				
N/A	Gutter Ponding?	N/A	N/A	Gutter Slope (%)	N/A	
N/A	Gutter Lip Ht (in)	N/A	N/A	Gutter X Slope (%)	N/A	
N/A	Painted X Walk1?	No	N/A	Painted X Walk2?	N/A	
	X Walk 1 Direction	To N		X Walk 2 Direction	N/A	
N/A	X Walk 1 Width (in)	N/A	N/A	X Walk 2 Width (in)	N/A	
	X Walk 1 Slope (%)	6.9		X Walk 2 Slope (%)	N/A

X Walk 1 X Slope (%)	1.9		X Walk 2 X Slope (%)	N/A	
N/A	Ramp inside XWalk1?	N/A	N/A	Ramp inside XWalk2?	N/A	
	Road Slope (%)	N/A	N/A	Clear Space?	N/A	
	Road X Slope (%)	N/A	N/A	Clear Space to XWalk (in)	N/A	
N/A	Any Obstructions?	N/A	N/A	Storm Grate/Utility Hazard	? <b>N/A</b>	
	Obstruction Type			Storm Grate/Utility Type		
		N/A			N/A	
			Yes	Surface Condition? (G/P)	Good

Possible Solutions:	
Possible Solutions.	<u> </u>
Remove & Replace Entire Ramp.	N
	N
	N
	N
	N
	N
Surveyor Notes:	N
N/A	N
	N
	1
	ı
PROW/ADA:	N
Not Found, R304.5.1, R304.2.2	N
	N
	N
	N
	,
	Remove & Replace Entire Ramp.  Surveyor Notes: N/A  PROW/ADA:
