Intersection ID: 12215	Main Street: MIDLAND_AV	Cross Street: DAVIS_AV	Location:	SW
ADA ID: 67C6D97BE36C	Ramp Type: Perp	Initial Pass/Fail: Fail	Overall Compliance: No	Severity Score: 26.25

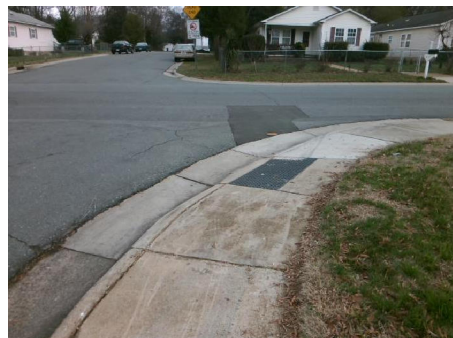
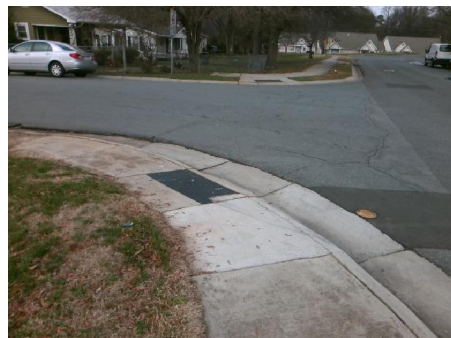
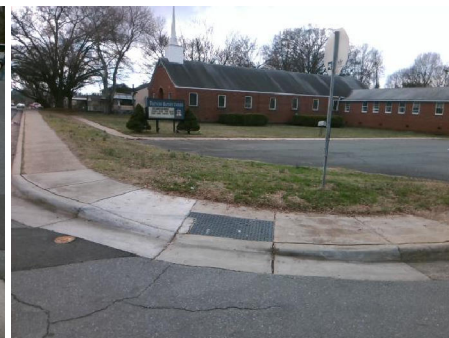
Not Found, R304.2.2, R304.5.3

Compliance	Description	Data	Compliance	Description	Data
N/A	Ramp Length (in)	48.0	No	Ramp Slope (%)	13.3
Yes	Ramp Width (in)	48.0	No	Ramp XSlope (%)	4.4
N/A	Flare Type LT	N/A	N/A	Flare Type RT	N/A
N/A	Flare Slope LT (%)	N/A	N/A	Flare Slope RT (%)	N/A
N/A	Flare Traversable LT?	N/A	N/A	Flare Traversable RT?	N/A
N/A	Landing Length (in)	N/A	N/A	DWS Provided?	N/A
N/A	Landing Width (in)	N/A	N/A	DWS Contrast?	N/A
N/A	Landing Slope (%)	N/A	N/A	DWS Length (in)	N/A
N/A	Landing X Slope (%)	N/A	N/A	DWS Full Width?	N/A
N/A	Landing Curb? (Y/N)	N/A	N/A	DWS Offset (in)	N/A
N/A	Shared Landing?	N/A			
N/A	Gutter Ponding?	N/A	N/A	Gutter Slope (%)	N/A
N/A	Gutter Lip Ht (in)	N/A	N/A	Gutter X Slope (%)	N/A
N/A	Painted X Walk1?	No	N/A	Painted X Walk2?	N/A
	X Walk 1 Direction	To N		X Walk 2 Direction	N/A
N/A	X Walk 1 Width (in)	N/A	N/A	X Walk 2 Width (in)	N/A
	X Walk 1 Slope (%)	0.1		X Walk 2 Slope (%)	N/A
	X Walk 1 X Slope (%)	3.8		X Walk 2 X Slope (%)	N/A

Remove & Replace Entire Ramp.
