Access Compliance Report

Public Rights-of-Way

(Curb Ramps)

Intersection ID: 9055	Main Street: DOGWOOD_AV	Cross Street: ENNIS_AV	Location: NW
ADA ID: 67FFD87B598F	Ramp Type: Combination2	Initial Pass/Fail: Fail	Overall Compliance: No
Severity Score: 22.5			
Codes/Mitigation Info/Possible Solution		Field Measurements/Component Compliance

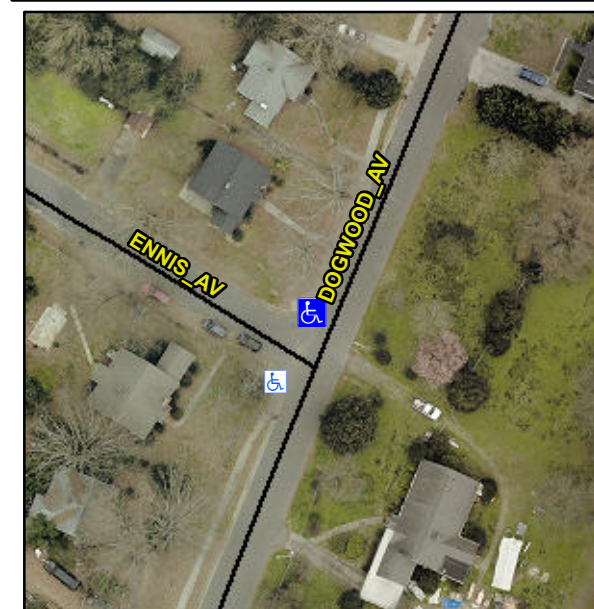
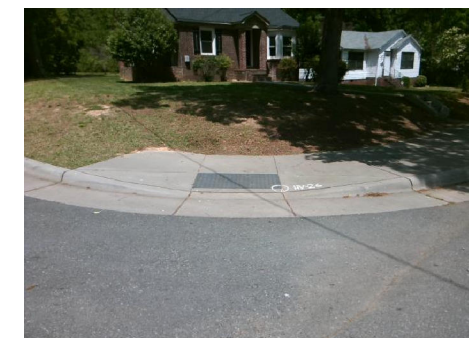
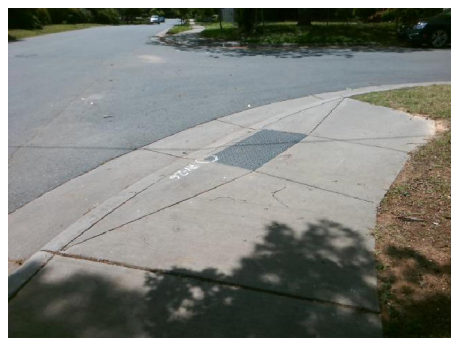
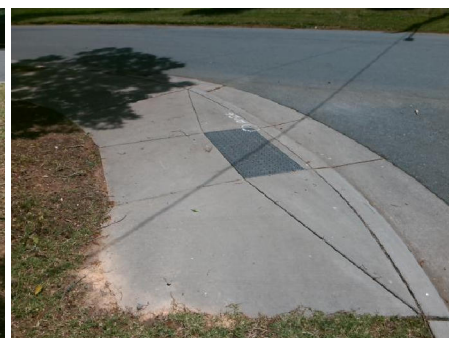
RT RP < 5%

Not Found, R304.5.1, R304.5.1, R304.5.3, R304.3.2

Compliance	Description	Data	Compliance	Description	Data
N/A	Ramp Length LT (in)	46.5	N/A	Ramp Length RT (in)	44.5
No	Ramp Width LT (in)	45.0	N/A	Ramp Width RT (in)	45.0
No	Ramp Slope LT (%)	9.6	N/A	Ramp Slope RT (%)	0.3
No	Ramp XSlope LT (%)	2.6	N/A	Ramp XSlope RT (%)	1.6
N/A	Ramp Length (in)	28.5	Yes	Ramp Slope (%)	6.6
No	Ramp Width (in)	47.5	No	Ramp XSlope (%)	3.7
N/A	Flare Type LT	N/A	N/A	Flare Type RT	N/A
N/A	Flare Slope LT (%)	N/A	N/A	Flare Slope RT (%)	N/A
N/A	Flare Traversable LT?	N/A	N/A	Flare Traversable RT?	N/A
N/A	Landing Length (in)	N/A	N/A	DWS Provided?	N/A
N/A	Landing Width (in)	N/A	N/A	DWS Contrast?	N/A
N/A	Landing Slope (%)	N/A	N/A	DWS Length (in)	N/A
N/A	Landing X Slope (%)	N/A	N/A	DWS Full Width?	N/A
N/A	Landing Curb? (Y/N)	N/A	N/A	DWS Offset (in)	N/A
N/A	Shared Landing?	N/A			
N/A	Gutter Ponding?	N/A	N/A	Gutter Slope (%)	N/A
N/A	Gutter Lip Ht (in)	N/A	N/A	Gutter X Slope (%)	N/A
N/A	Painted X Walk1?	No	N/A	Painted X Walk2?	N/A

Remove & Replace Entire Ramp.
