Access Compliance Report

Public Rights-of-Way

(Curb Ramps)

Intersection ID: 43138	Main Street: ASBURY_AV	Cross Street: ATANDO_AV	Location: NE
ADA ID: 68027F4B9798	Ramp Type: ParaDiag	Initial Pass/Fail: Fail	Overall Compliance: No
Severity Score: 13.75			
Codes/Mitigation Info/Possible Solution		Field Measurements/Component Compliance

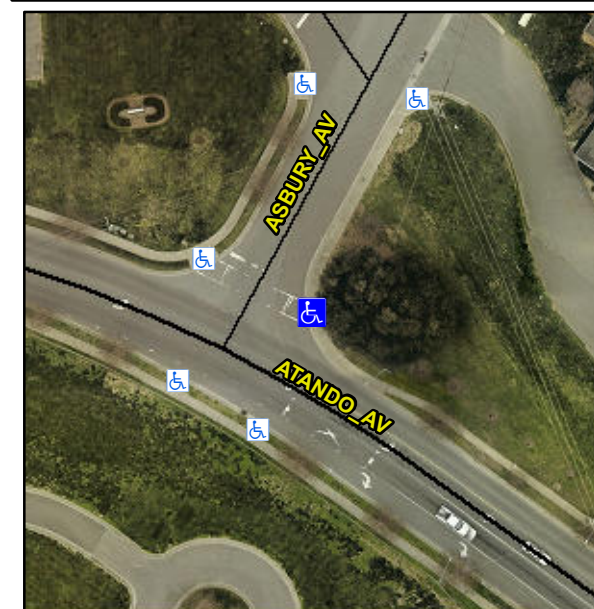
R304.3.2, R304.5.3

Compliance	Description	Data	Compliance	Description	Data
N/A	Ramp Length LT (in)	N/A	N/A	Ramp Length RT (in)	60.0
N/A	Ramp Width LT (in)	N/A	Yes	Ramp Width RT (in)	59.0
N/A	Ramp Slope LT (%)	N/A	No	Ramp Slope RT (%)	9.5
N/A	Ramp XSlope LT (%)	N/A	No	Ramp XSlope RT (%)	3.0
N/A	Landing Length (in)	N/A	N/A	DWS Provided?	N/A
N/A	Landing Width (in)	N/A	N/A	DWS Contrast?	N/A
N/A	Landing Slope (%)	N/A	N/A	DWS Length (in)	N/A
N/A	Landing X Slope (%)	N/A	N/A	DWS Full Width?	N/A
N/A	Landing Curb? (Y/N)	N/A	N/A	DWS Offset (in)	N/A
N/A	Shared Landing?	N/A			
N/A	Gutter Ponding?	N/A	N/A	Gutter Slope (%)	N/A
N/A	Gutter Lip Ht (in)	N/A	N/A	Gutter X Slope (%)	N/A
N/A	Painted X Walk1?	No	N/A	Painted X Walk2?	No
	X Walk 1 Direction	To NW		X Walk 2 Direction	To SW
N/A	X Walk 1 Width (in)	N/A	N/A	X Walk 2 Width (in)	N/A
	X Walk 1 Slope (%)	4.9		X Walk 2 Slope (%)	0.2
	X Walk 1 X Slope (%)	0.6		X Walk 2 X Slope (%)	3.5
N/A	Ramp inside XWalk1?	N/A	N/A	Ramp inside XWalk2?	N/A

Remove & Replace Curb Ramp With Two New Directional Ramps or Equivalent.
