# Access Compliance Report

## Public Rights-of-Way

### (Curb Ramps)

| Intersection ID: 53253 | Main Street: MARLOWE_AV | Cross Street: ALYSSA_LN | Location: NE |

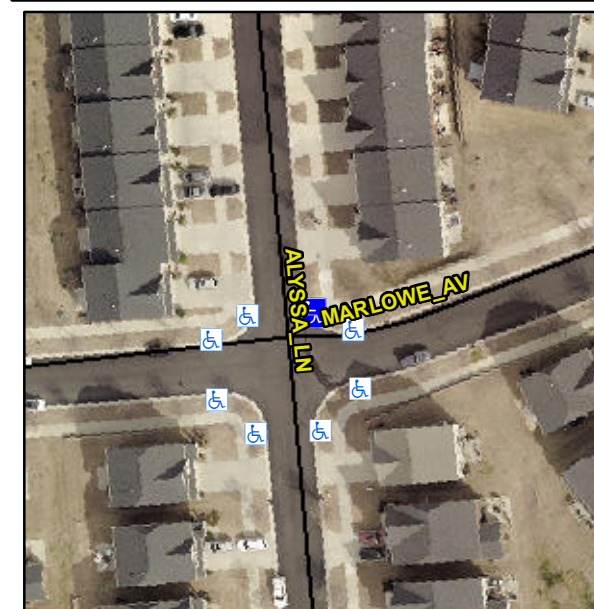
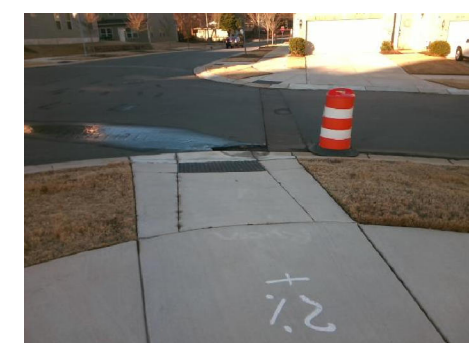
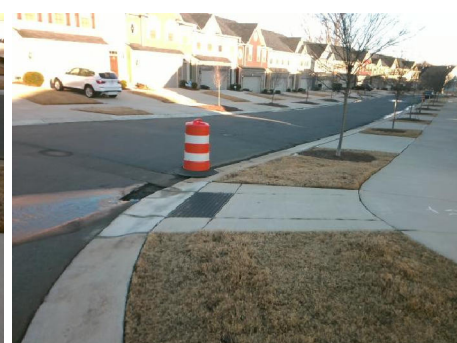
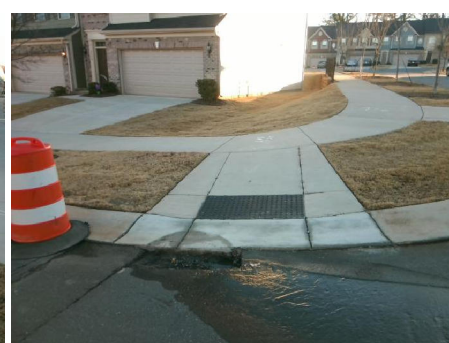
| ADA ID: 680F63FF22F2 | Ramp Type: Perp | Initial Pass/Fail: Fail | Overall Compliance: No |

**Not Found, R304.5.1, R304.2.2, R304.5.3**

| Compliance | Description | Data | Compliance | Description | Data |
|---|---|---|---|---|---|
| N/A | Ramp Length (in) | 96.5 | No | Ramp Slope (%) | 10.5 |
| No | Ramp Width (in) | 47.0 | No | Ramp XSlope (%) | 11.4 |

**Remove & Replace Entire Ramp.**
