# Access Compliance Report

## Public Rights-of-Way

### (Curb Ramps)

| Intersection ID: 11799 | Main Street: MECKLENBURG_AV | Cross Street: NORCROSS_PL | Location: | S |

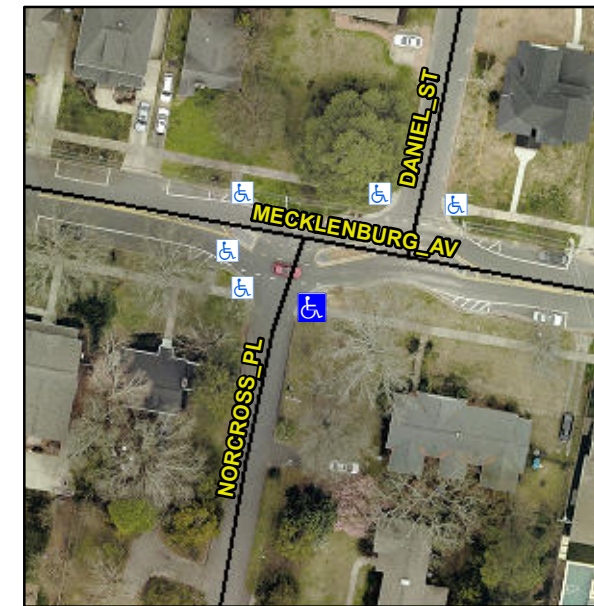
| ADA ID: 68870FCFFAE8 | Ramp Type: Directional1 | Initial Pass/Fail: Pass | Overall Compliance: No | Severity Score: 5 |

**R304.5.3, R305.2, R302.7, R304.5.4**

| Compliance | Description | Data | Compliance | Description | Data |
|---|---|---|---|---|---|
| Yes | Ramp Width (in) | 62.0 | No | Grade Break Slope (%) | 5.5 |
| N/A | Landing Curb? (Y/N) | N/A | No | DWS Offset LT (in) | 4.0 |
| No | Gutter Ponding? | Yes | No | Gutter Slope (%) | 8.3 |

**Remove & Replace Entire Ramp.  
Remove & Replace Gutter.**
