Access Compliance Report

Public Rights-of-Way

(Curb Ramps)

| Intersection ID: 46951 | Main Street: PROVIDENCE_RD | Cross Street: OLDE_WHITE_LN | Location: SW |

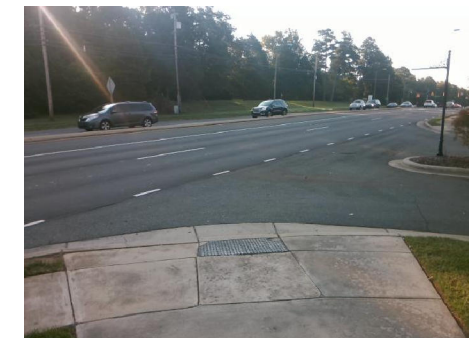
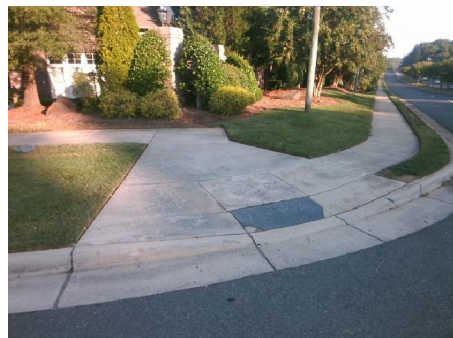
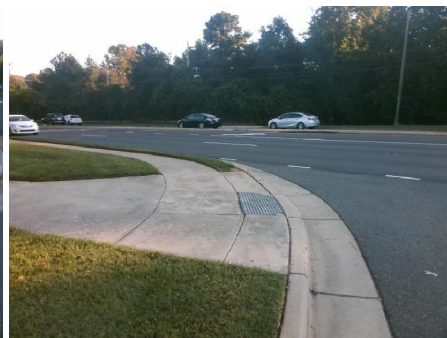
LT RP < 5%

R304.5.1, R304.5.3

| Compliance | Description | Data | Compliance | Description | Data |
|---|---|---|---|---|---|
| No | Ramp Width LT (in) | 47.0 | No | Ramp Width RT (in) | 46.0 |
| No | Ramp XSlope LT (%) | 2.9 | No | Ramp XSlope RT (%) | 2.6 |

**Remove & Replace Entire Ramp.
Remove & Replace Sidewalk.**
