# Access Compliance Report

## Public Rights-of-Way

### (Curb Ramps)

| Intersection ID: 16333 | Main Street: AUBURN_AV | Cross Street: HARTFORD_AV | Location: | E |

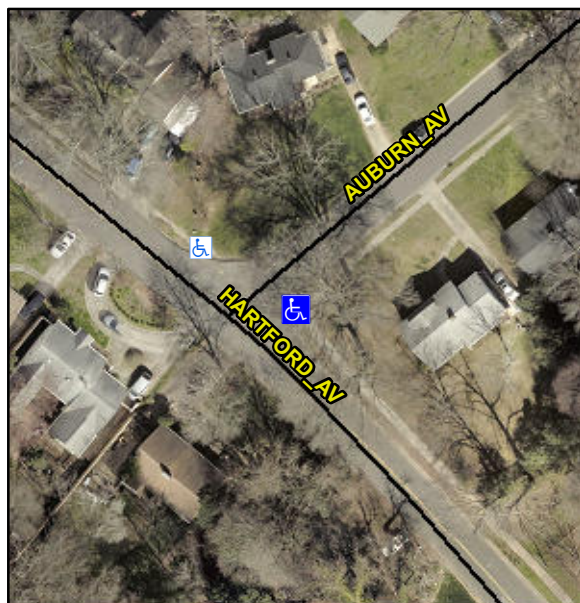
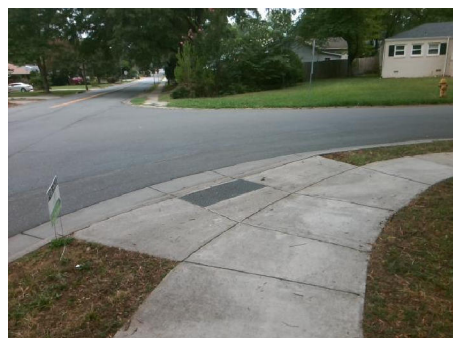
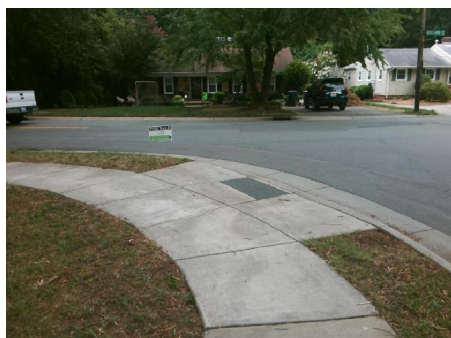
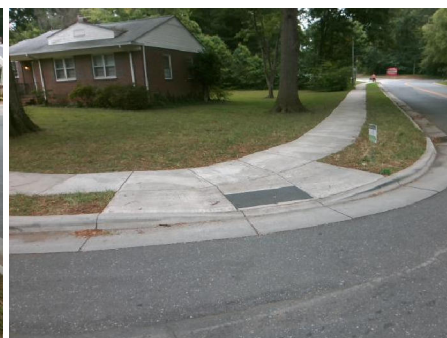
| ADA ID: 690FAA67822F | Ramp Type: Combination1Diag | Initial Pass/Fail: Pass | Overall Compliance: No | Severity Score: 20 |

**Not Found, R304.5.3, R304.2.1, R304.2.2-Perp, R304.3.2-Para, R305.2, R302.7.2, R304.5.4**

| Compliance | Description | Data | Compliance | Description | Data |
|---|---|---|---|---|---|
| Yes | Ramp XSlope LT (%) | 1.6 | No | Ramp XSlope RT (%) | 2.6 |
| No | Landing Width (in) | 46.0 | Yes | DWS Contrast? | Yes |
| No | Landing Slope (%) | 3.2 | Yes | DWS Length (in) | 24.5 |
| No | Landing X Slope (%) | 2.4 | Yes | DWS Full Width? | Yes |
| N/A | Landing Curb? (Y/N) | No | No | DWS Offset (in) | 4.0 |
| Yes | Gutter Ponding? | No | No | Gutter Slope (%) | 5.4 |
| No | Gutter Lip Ht (in) | 1.0 | Yes | Gutter X Slope (%) | 0.7 |

**Remove & Replace Curb Ramp With Two New Directional Ramps or Equivalent. Remove & Replace Gutter.**
