Access Compliance Report

Public Rights-of-Way

(Curb Ramps)

| Intersection ID: 50321 | Main Street: BELMAR_PLACE_RD | Cross Street: CINDY_LN | Location: NW |

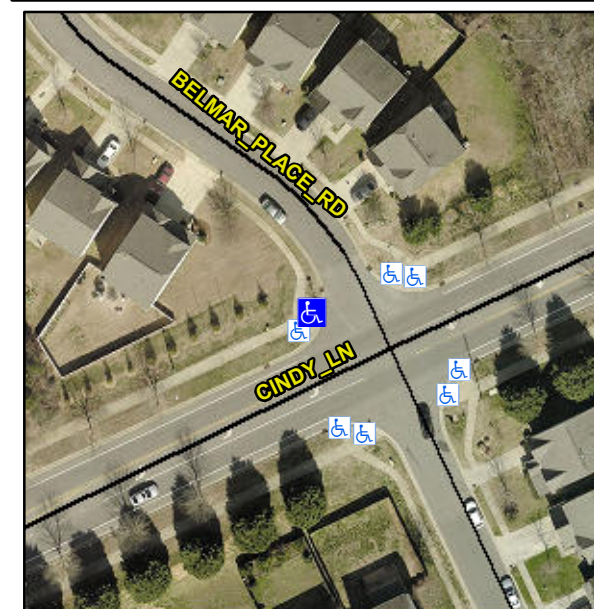
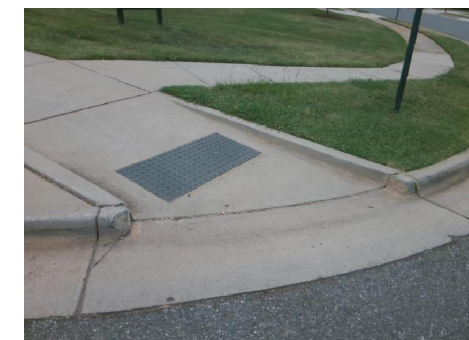
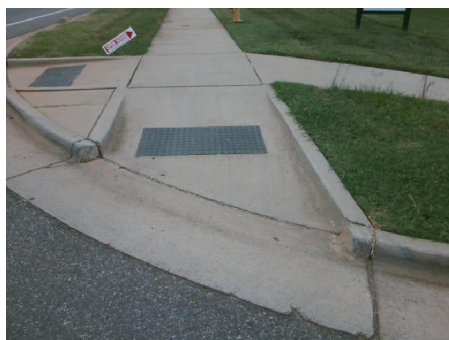
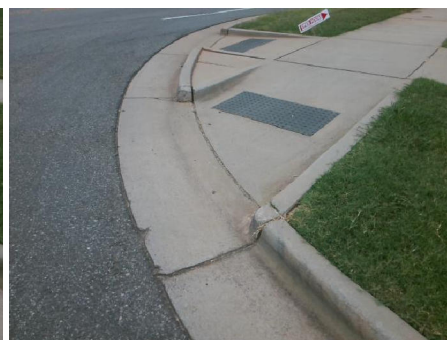
| ADA ID: 691440BB7F98 | Ramp Type: Directional1 | Initial Pass/Fail: Fail | Overall Compliance: No |
| Severity Score: 12.5 | | | |

R304.2.2

| Compliance | Description | Data | Compliance | Description | Data |
|---|---|---|---|---|---|
| No | Ramp Slope (%) | 10.0 | N/A | Grade Break XSlope (%) | 0.0 |

Remove & Replace Entire Ramp.
