Access Compliance Report

Public Rights-of-Way

(Curb Ramps)

Intersection ID: 10025681	Main Street: EAST_BV	Cross Street: N/A	Location: SW
ADA ID: 69379D0ACC3B	Ramp Type: Perp	Initial Pass/Fail: Fail	Overall Compliance: No
			Severity Score: 13.75

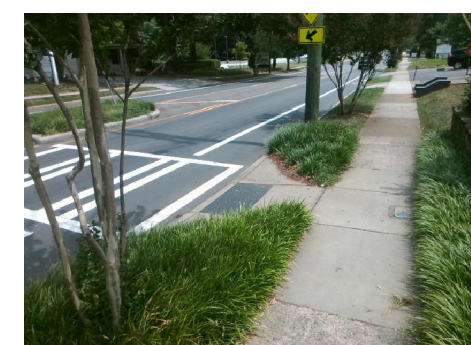
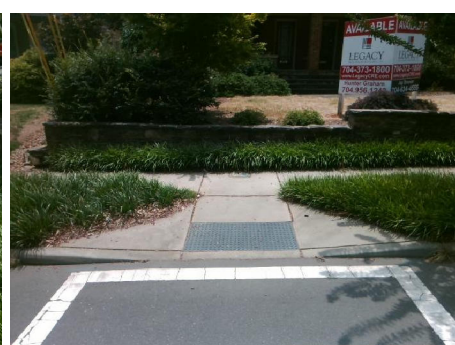
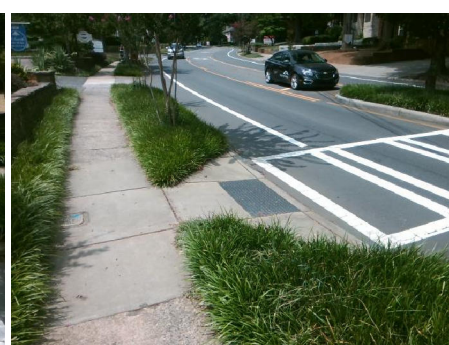
Possible Solutions:		Compliance	Description	Data
	Remove & Replace Entire Ramp.		No	Ramp Slope (%)	9.1
			Yes	Ramp Width (in)	2.7
			N/A	Flare Type LT	N/A
			N/A	Flare Slope LT (%)	N/A
			N/A	Flare Traversable LT?	N/A
			N/A	Landing Length (in)	N/A
			N/A	Landing Width (in)	N/A
			N/A	Landing Slope (%)	N/A
			N/A	Landing X Slope (%)	N/A
<p>Surveyor Notes:</p> <p>N/A</p> <p>PROW/ADA:</p> <p>Not Found, R304.2.2</p>			N/A	Flare Type RT	N/A
			N/A	Flare Slope RT (%)	N/A
			N/A	Flare Traversable RT?	N/A
			N/A	DWS Provided?	N/A
			N/A	DWS Contrast?	N/A
			N/A	DWS Length (in)	N/A
			N/A	DWS Full Width?	N/A
			N/A	DWS Offset (in)	N/A
			N/A	Gutter Ponding?	N/A
			N/A	Gutter Lip Ht (in)	N/A
			Yes	Painted X Walk1?	N/A
			To NE	X Walk 2 Direction	N/A
			N/A	X Walk 2 Width (in)	N/A

1.9	X Walk 2 Slope (%)	N/A
			4.0	X Walk 2 X Slope (%)	N/A
			N/A	Ramp inside XWalk2?	N/A
			N/A	Clear Space?	N/A
			N/A	Clear Space to XWalk (in)	N/A
			N/A	Storm Grate/Utility Hazard?	N/A
			N/A	Storm Grate/Utility Type	N/A
Total Cost:		\$ 1850.00			
			N/A		N/A
			Yes	Surface Condition? (G/P)	Good
