Access Compliance Report

Public Rights-of-Way

(Curb Ramps)

Intersection ID: 45239	Main Street: BROOKWOOD_RD	Cross Street: CALDWELL_RD	Location: S
ADA ID: 6943C539ECA5	Ramp Type: Combination1	Initial Pass/Fail: Fail	Overall Compliance: No
		Severity Score: 22.5

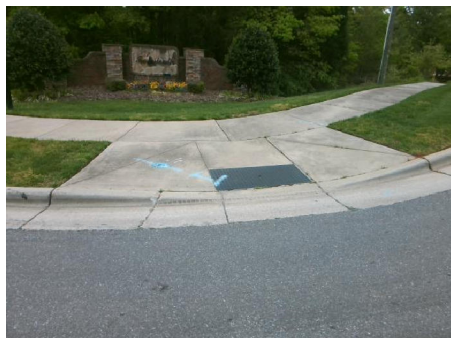
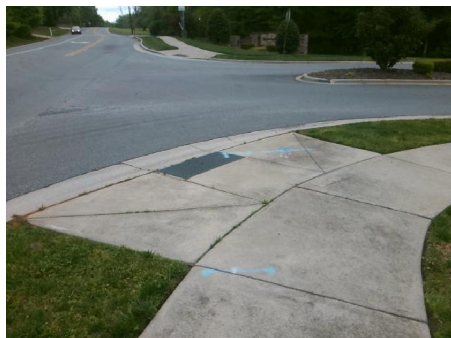
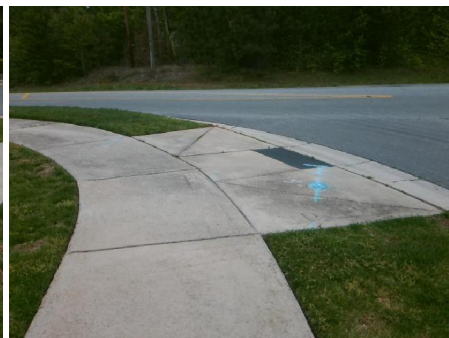
CURB GAP 1.0

Not Found, R304.5.1, R304.5.3, R304.3.2

Compliance	Description	Data	Compliance	Description	Data
N/A	Ramp Length LT (in)	34.5	N/A	Ramp Length RT (in)	34.5
Yes	Ramp Width LT (in)	55.0	Yes	Ramp Width RT (in)	55.5
Yes	Ramp Slope LT (%)	6.5	No	Ramp Slope RT (%)	10.1
No	Ramp XSlope LT (%)	4.4	No	Ramp XSlope RT (%)	3.0
N/A	Ramp Length (in)	76.0	Yes	Ramp Slope (%)	4.0
No	Ramp Width (in)	47.5	No	Ramp XSlope (%)	4.9
N/A	Flare Type LT	N/A	N/A	Flare Type RT	N/A
N/A	Flare Slope LT (%)	N/A	N/A	Flare Slope RT (%)	N/A
N/A	Flare Traversable LT?	N/A	N/A	Flare Traversable RT?	N/A
N/A	Landing Length (in)	N/A	N/A	DWS Provided?	N/A
N/A	Landing Width (in)	N/A	N/A	DWS Contrast?	N/A
N/A	Landing Slope (%)	N/A	N/A	DWS Length (in)	N/A
N/A	Landing X Slope (%)	N/A	N/A	DWS Full Width?	N/A
N/A	Landing Curb? (Y/N)	N/A	N/A	DWS Offset (in)	N/A
N/A	Shared Landing?	N/A			
N/A	Gutter Ponding?	N/A	N/A	Gutter Slope (%)	N/A
N/A	Gutter Lip Ht (in)	N/A	N/A	Gutter X Slope (%)	N/A
N/A	Painted X Walk1?	No	N/A	Painted X Walk2?	N/A

Remove & Replace Entire Ramp.
