Access Compliance Report

Public Rights-of-Way

(Curb Ramps)

| Intersection ID: 29271 | Main Street: IRON_BRIGADE_LN | Cross Street: LAKOTA_CT | Location: E |

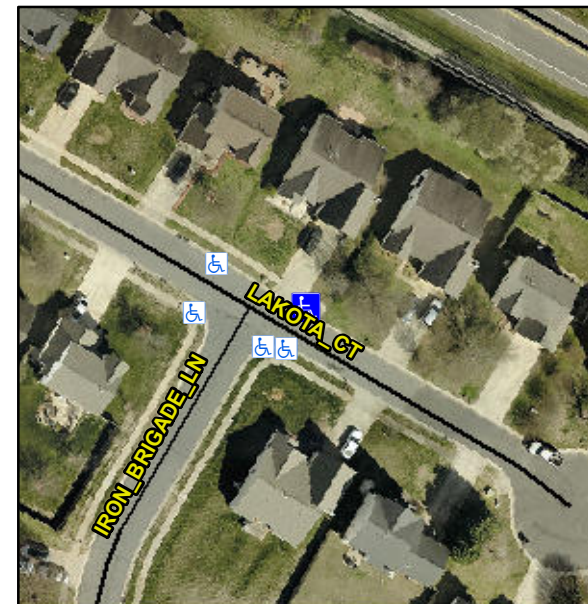
| ADA ID: 69BC42D3D7D6 | Ramp Type: Perp | Initial Pass/Fail: Fail | Overall Compliance: No |
| Severity Score: 26.25 | | | |

R304.2.2, R304.5.3

| Compliance | Description | Data | Compliance | Description | Data |
|---|---|---|---|---|---|
| N/A | Ramp Length (in) | 48.0 | No | Ramp Slope (%) | 12.0 |
| Yes | Ramp Width (in) | 48.0 | No | Ramp XSlope (%) | 3.3 |

Remove & Replace Entire Ramp.
