# Access Compliance Report

## Public Rights-of-Way

| Intersection ID: 7195 | Main Street: REAGAN_DR | Cross Street: TOM_HUNTER_RD | Location: SE |
| ADA ID: 6A0E0DD3EC38 | Ramp Type: Para | Initial Pass/Fail: Fail | Overall Compliance: No |

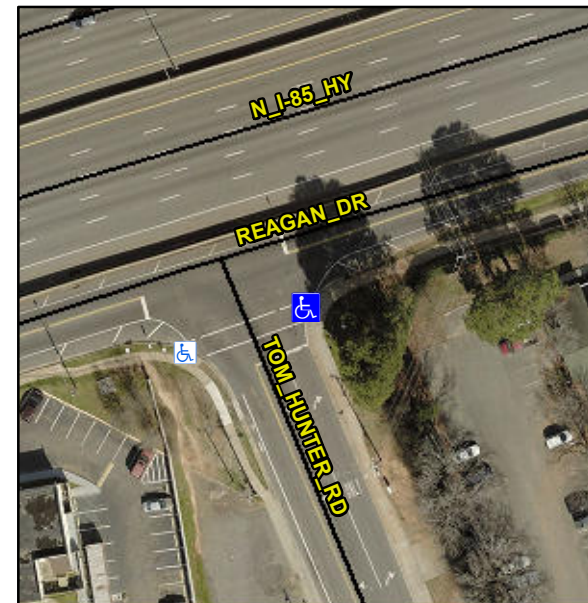
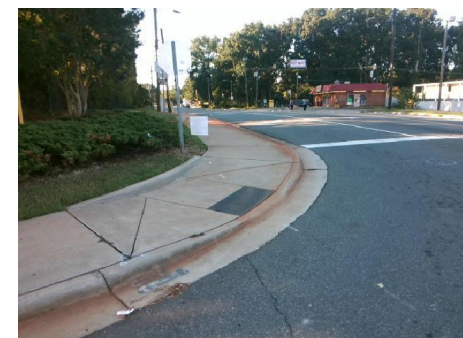
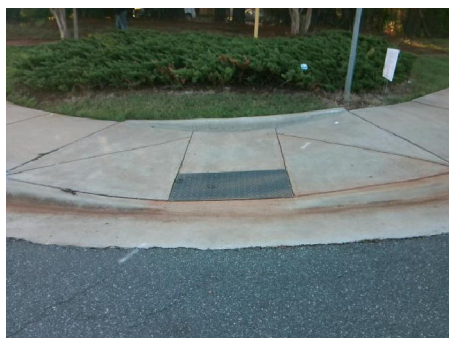
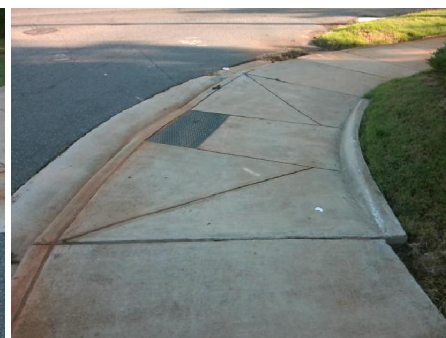
| Severity Score: 26.25 | | | |

**R304.3.2, R304.5.3**

| Compliance | Description | Data | Compliance | Description | Data |
|---|---|---|---|---|---|
| Yes | Ramp Slope LT (%) | 5.4 | No | Ramp Slope RT (%) | 18.2 |
| Yes | Ramp XSlope LT (%) | 1.4 | No | Ramp XSlope RT (%) | 3.8 |

**Remove & Replace Entire Ramp.**

Total Cost: \$ 1600.00
