## Access Compliance Report Public Rights-of-Way (Curb Ramps)

Intersection ID: 43113 Main Street: HELTON\_WY Cross Street: LAMAR\_AV Location: NW

ADA ID: 6A9CBBEB693E Ramp Type: Perp Initial Pass/Fail: Fail Overall Compliance: No Severity Score: 13.75

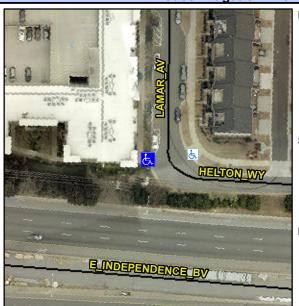
1 CSSIDIC COIGHOIL	
Possible Solutions:	Comp
Remove & Replace Entire Ramp.	N/A
·	Yes
	N/A
	N/A
	N/A
	N/A
Surveyor Notes:	N/A
N/A	N/A
	N/A
	N/A
	N/A
PROW/ADA:	N/A
Not Found, R304.2.2	N/A
,	N/A
	N/A
	N/A

Field Measurements/Component Compliance						
Comp	liance Description	Data	Comp	liance Description	Data	
N/A	Ramp Length (in)	98.0	No	Ramp Slope (%)	8.4	
Yes	Ramp Width (in)	60.0	Yes	Ramp XSlope (%)	3.2	
N/A	Flare Type LT	N/A	N/A	Flare Type RT	N/A	
N/A	Flare Slope LT (%)	N/A	N/A	Flare Slope RT (%)	N/A	
N/A	Flare Traversable LT?	N/A	N/A	Flare Traversable RT?	N/A	
N/A	Landing Length (in)	N/A	N/A	DWS Provided?	N/A	
N/A	Landing Width (in)	N/A	N/A	DWS Contrast?	N/A	
N/A	Landing Slope (%)	N/A	N/A	DWS Length (in)	N/A	
N/A	Landing X Slope (%)	N/A	N/A	DWS Full Width?	N/A	
N/A	Landing Curb? (Y/N)	N/A	N/A	DWS Offset (in)	N/A	
N/A	Shared Landing?	N/A				
N/A	Gutter Ponding?	N/A	N/A	Gutter Slope (%)	N/A	
N/A	Gutter Lip Ht (in)	1.0	N/A	Gutter X Slope (%)	N/A	
N/A	Painted X Walk1?	No	N/A	Painted X Walk2?	N/A	
	X Walk 1 Direction	To E		X Walk 2 Direction	N/A	
N/A	X Walk 1 Width (in)	N/A	N/A	X Walk 2 Width (in)	N/A	
	X Walk 1 Slope (%)	4.9		X Walk 2 Slope (%)	N/A
