Access Compliance Report

Public Rights-of-Way (Curb Ramps)

Intersection ID: 9716	Main Street: N_GREGG_ST	Cross Street: W_TRADE_ST	Location: W
ADA ID: 6B266AEE43C8	Ramp Type: Combination1	Initial Pass/Fail: Fail	Overall Compliance: No
			Severity Score: 46.25

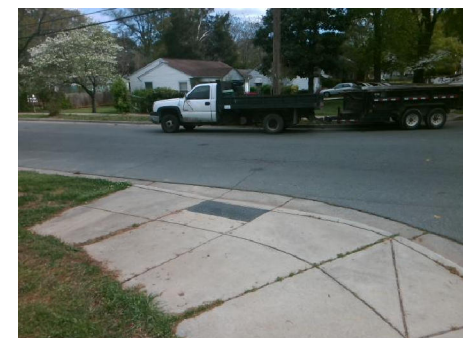
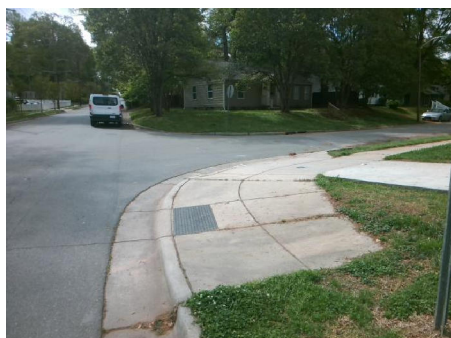
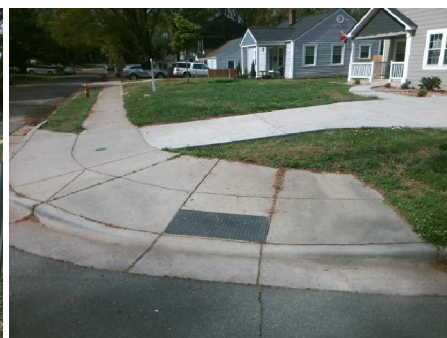
RT RP < 5%

Not Found, R304.5.1, R304.2.2, R304.5.3

Compliance	Description	Data	Compliance	Description	Data
N/A	Ramp Length LT (in)	33.0	N/A	Ramp Length RT (in)	52.0
Yes	Ramp Width LT (in)	62.0	Yes	Ramp Width RT (in)	62.0
Yes	Ramp Slope LT (%)	5.0	Yes	Ramp Slope RT (%)	4.3
No	Ramp XSlope LT (%)	7.4	No	Ramp XSlope RT (%)	6.6
N/A	Ramp Length (in)	108.0	No	Ramp Slope (%)	9.2
No	Ramp Width (in)	46.5	No	Ramp XSlope (%)	4.2
N/A	Flare Type LT	N/A	N/A	Flare Type RT	N/A
N/A	Flare Slope LT (%)	N/A	N/A	Flare Slope RT (%)	N/A
N/A	Flare Traversable LT?	N/A	N/A	Flare Traversable RT?	N/A
N/A	Landing Length (in)	N/A	N/A	DWS Provided?	N/A
N/A	Landing Width (in)	N/A	N/A	DWS Contrast?	N/A
N/A	Landing Slope (%)	N/A	N/A	DWS Length (in)	N/A
N/A	Landing X Slope (%)	N/A	N/A	DWS Full Width?	N/A
N/A	Landing Curb? (Y/N)	N/A	N/A	DWS Offset (in)	N/A
N/A	Shared Landing?	N/A			
N/A	Gutter Ponding?	N/A	N/A	Gutter Slope (%)	N/A
N/A	Gutter Lip Ht (in)	N/A	N/A	Gutter X Slope (%)	N/A
N/A	Painted X Walk1?	No	N/A	Painted X Walk2?	N/A

Remove & Replace Entire Ramp.
