# Access Compliance Report

## Public Rights-of-Way

### (Curb Ramps)

| Intersection ID: N/A | Main Street: BEREWICK COMMONS PKY | Cross Street: GLENBURN LN | Location: NE |

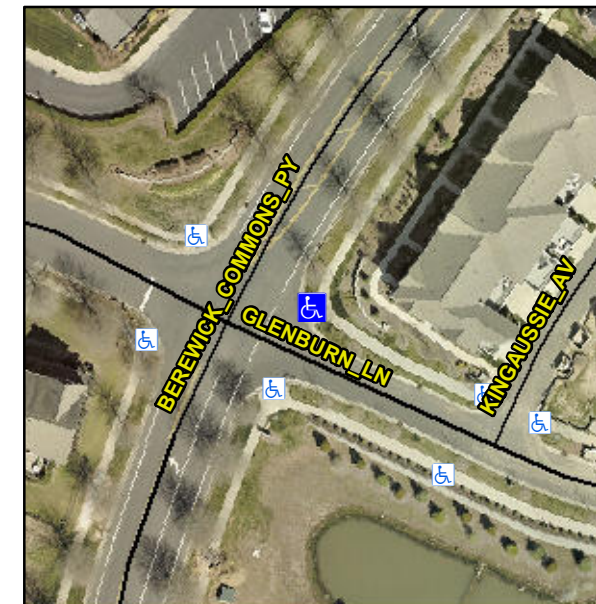
**Not Found, R305.2**

| Compliance | Description | Data | Compliance | Description | Data |
|---|---|---|---|---|---|
| N/A | Landing Curb? (Y/N) | No | No | DWS Offset (in) | 4.0 |

**Remove & Replace Curb Ramp With Two New Directional Ramps or Equivalent.**
