Access Compliance Report

Public Rights-of-Way

(Curb Ramps)

Intersection ID: 47853	Main Street: EL_CAMPO_CT	Cross Street: STONE_PORCH_RD	Location: SW
ADA ID: 6BCCD598EB8A	Ramp Type: PerpDiag	Initial Pass/Fail: Fail	Overall Compliance: No
Severity Score: 35			
Codes/Mitigation Info/Possible Solution		Field Measurements/Component Compliance

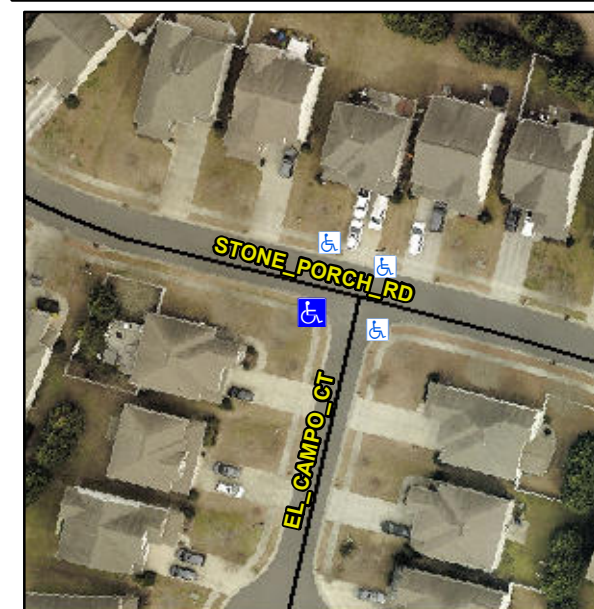
Not Found, R304.5.1, R304.2.2, R304.5.3

Compliance	Description	Data	Compliance	Description	Data
N/A	Ramp Length (in)	48.0	No	Ramp Slope (%)	12.0
No	Ramp Width (in)	45.0	No	Ramp XSlope (%)	2.9
N/A	Flare Type LT	N/A	N/A	Flare Type RT	N/A
N/A	Flare Slope LT (%)	N/A	N/A	Flare Slope RT (%)	N/A
N/A	Flare Traversable LT?	N/A	N/A	Flare Traversable RT?	N/A
N/A	Landing Length (in)	N/A	N/A	DWS Provided?	N/A
N/A	Landing Width (in)	N/A	N/A	DWS Contrast?	N/A
N/A	Landing Slope (%)	N/A	N/A	DWS Length (in)	N/A
N/A	Landing X Slope (%)	N/A	N/A	DWS Full Width?	N/A
N/A	Landing Curb? (Y/N)	N/A	N/A	DWS Offset (in)	N/A
N/A	Shared Landing?	N/A			
N/A	Gutter Ponding?	N/A	N/A	Gutter Slope (%)	N/A
N/A	Gutter Lip Ht (in)	N/A	N/A	Gutter X Slope (%)	N/A
N/A	Painted X Walk1?	No	N/A	Painted X Walk2?	No
	X Walk 1 Direction	To SE		X Walk 2 Direction	To NE
N/A	X Walk 1 Width (in)	N/A	N/A	X Walk 2 Width (in)	N/A
	X Walk 1 Slope (%)	1.3		X Walk 2 Slope (%)	2.7
	X Walk 1 X Slope (%)	0.8		X Walk 2 X Slope (%)	1.0

N/A	Ramp inside XWalk1?	N/A	N/A	Ramp inside XWalk2?	N/A
	Road Slope (%)	1.4	N/A	Clear Space?	N/A
	Road X Slope (%)	0.8	N/A	Clear Space to XWalk (in)	N/A
N/A	Any Obstructions?	N/A	N/A	Storm Grate/Utility Hazard?	N/A
	Obstruction Type			Storm Grate/Utility Type	
		N/A			N/A
			Yes	Surface Condition? (G/P)	Good

Possible Solutions:

Remove & Replace Curb Ramp With Two New Directional Ramps or Equivalent.
