Access Compliance Report

Public Rights-of-Way

| Intersection ID: 27772 | Main Street: BRIARWICK_LN | Cross Street: NORTH_COMMUNITY_HOUSE_RD | Location: SE |
| ADA ID: 6C7040CD9717 | Ramp Type: Perp | Initial Pass/Fail: Fail | Overall Compliance: No |

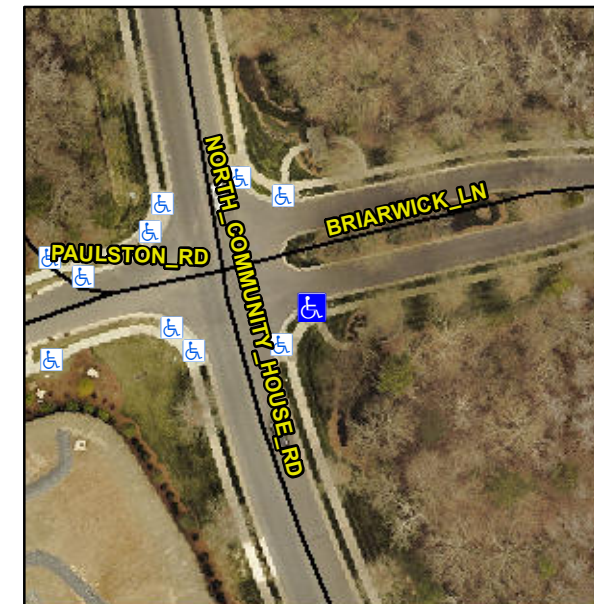
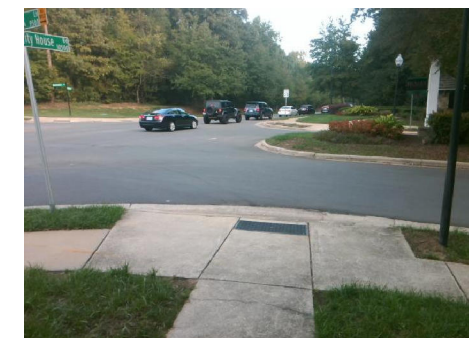
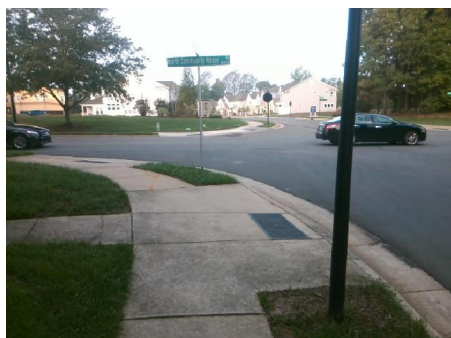
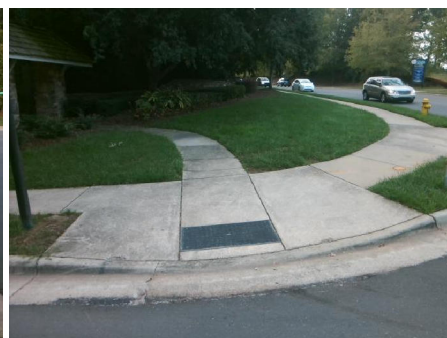
| Severity Score: 37.5 | | | |

R304.2.2, R304.5.3

| Compliance | Description | Data | Compliance | Description | Data |
|---|---|---|---|---|---|
| N/A | Ramp Length (in) | 106.0 | No | Ramp Slope (%) | 11.7 |
| Yes | Ramp Width (in) | 49.0 | No | Ramp XSlope (%) | 8.3 |

Remove & Replace Entire Ramp.
