# Access Compliance Report

## Public Rights-of-Way

### (Curb Ramps)

Intersection ID: N/A	Main Street: CRAIGHEAD_RD	Cross Street: N/A	Location: NW
ADA ID: 6CE2515C5A10	Ramp Type: Combination2Diag	Initial Pass/Fail: Fail	Overall Compliance: No
		Severity Score: 0

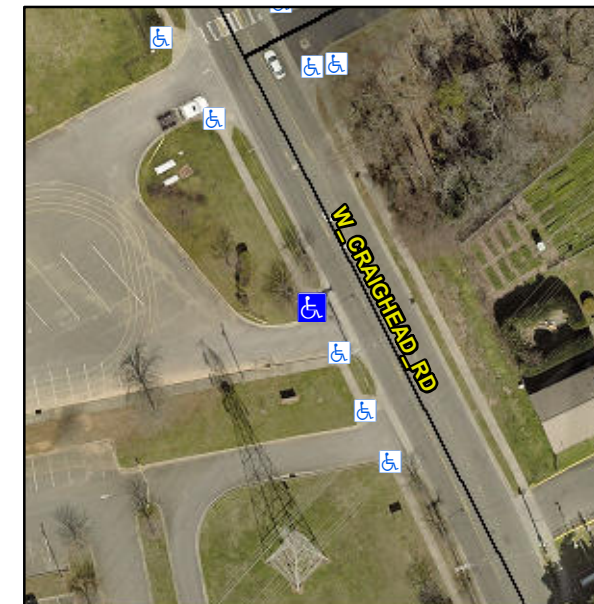
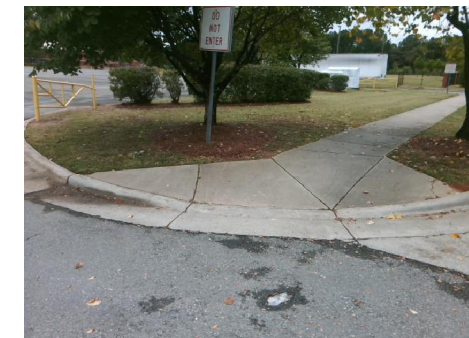
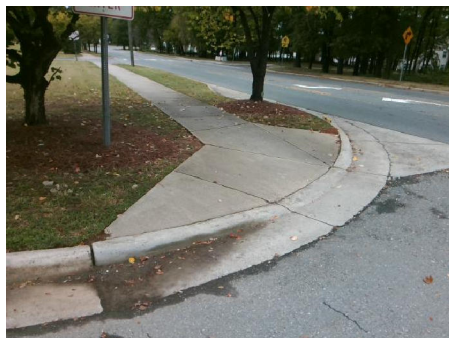
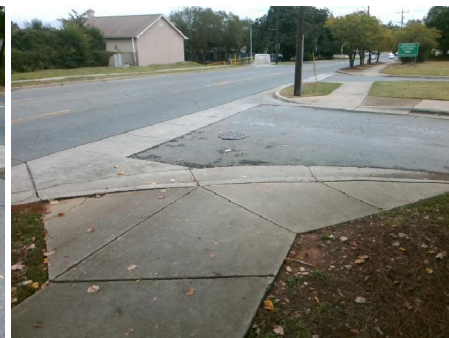
**Not Found, R304.2.2, R304.5.3**

Compliance	Description	Data	Compliance	Description	Data
N/A	Ramp Length LT (in)	N/A	N/A	Ramp Length RT (in)	34.0
N/A	Ramp Width LT (in)	N/A	Yes	Ramp Width RT (in)	66.0
N/A	Ramp Slope LT (%)	N/A	Yes	Ramp Slope RT (%)	8.1
N/A	Ramp XSlope LT (%)	N/A	No	Ramp XSlope RT (%)	4.0
N/A	Ramp Length (in)	58.0	No	Ramp Slope (%)	10.5
Yes	Ramp Width (in)	51.0	No	Ramp XSlope (%)	5.5
N/A	Flare Type LT	N/A	N/A	Flare Type RT	N/A
N/A	Flare Slope LT (%)	N/A	N/A	Flare Slope RT (%)	N/A
N/A	Flare Traversable LT?	N/A	N/A	Flare Traversable RT?	N/A
N/A	Landing Length (in)	N/A	N/A	DWS Provided?	N/A
N/A	Landing Width (in)	N/A	N/A	DWS Contrast?	N/A
N/A	Landing Slope (%)	N/A	N/A	DWS Length (in)	N/A
N/A	Landing X Slope (%)	N/A	N/A	DWS Full Width?	N/A
N/A	Landing Curb? (Y/N)	N/A	N/A	DWS Offset (in)	N/A
N/A	Shared Landing?	N/A			
N/A	Gutter Ponding?	N/A	N/A	Gutter Slope (%)	N/A
N/A	Gutter Lip Ht (in)	N/A	N/A	Gutter X Slope (%)	N/A
N/A	Painted X Walk1?	No	N/A	Painted X Walk2?	No

**Remove & Replace Curb Ramp With Two New Directional Ramps or Equivalent.**
