## **Access Compliance Report Public Rights-of-Way** (Curb Ramps)

Intersection ID: N/A Main Street: SPEER\_BV Cross Street: MILLENNIUM\_AV Location: SW ADA ID: 6D811054C373 Ramp Type: Directional1 Initial Pass/Fail: Fail **Overall Compliance: No Severity Score:** 12.5

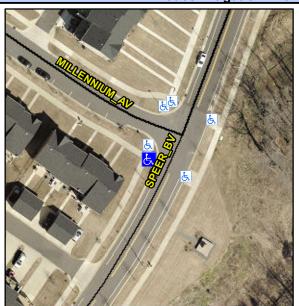
Field Measurements/Component Compliance									
Compl	iance Description	Data	Compli	ance Description	Data				
N/A	Ramp Length (in)	72.0	N/A	Grade Break?	N/A				
Yes	Ramp Width (in)	70.0	N/A	Grade Break Slope (%)	0.0				
No	Ramp Slope (%)	9.0	N/A	Grade Break XSlope (%)	0.0				
Yes	Ramp XSlope (%)	1.0							
N/A	Flare Type LT	N/A	N/A	Flare Type RT	N/A				
N/A	Flare Slope LT (%)	N/A	N/A	Flare Slope RT (%)	0.0				
N/A	Flare Traversable LT?	N/A	N/A	Flare Traversable RT?	N/A				
N/A	Landing Length (in)	0.0	N/A	DWS Provided?	N/A				
N/A	Landing Width (in)	0.0	N/A	DWS Contrast?	N/A				
N/A	Landing Slope (%)	0.0	N/A	DWS Length (in)	N/A				
N/A	Landing X Slope (%)	0.0	N/A	DWS Full Width?	N/A				
N/A	Landing Curb? (Y/N)	N/A	N/A	DWS Offset LT (in)	N/A				
N/A	Shared Landing?	N/A	N/A	DWS Offset RT (in)	N/A				
N/A	Gutter Ponding?	0.0	N/A	Gutter Slope (%)	N/A				
N/A	Gutter Lip Ht (in)	0.0	N/A	Gutter X Slope (%)	N/A

1	Possible Solutions:				
1	Remove & Replace Entire Ramp.				
A.O.					
1					
19					
	Surveyor Notes:				
200	N/A				
No.					
S. S. Cont.					
1	PROW/ADA:				
	R304.2.2				
-					
Š
